The Keowee Creeper

By Daryl Wurster, PE and
Doug Chappell, PE

Wurster Engineering & Construction, Inc.

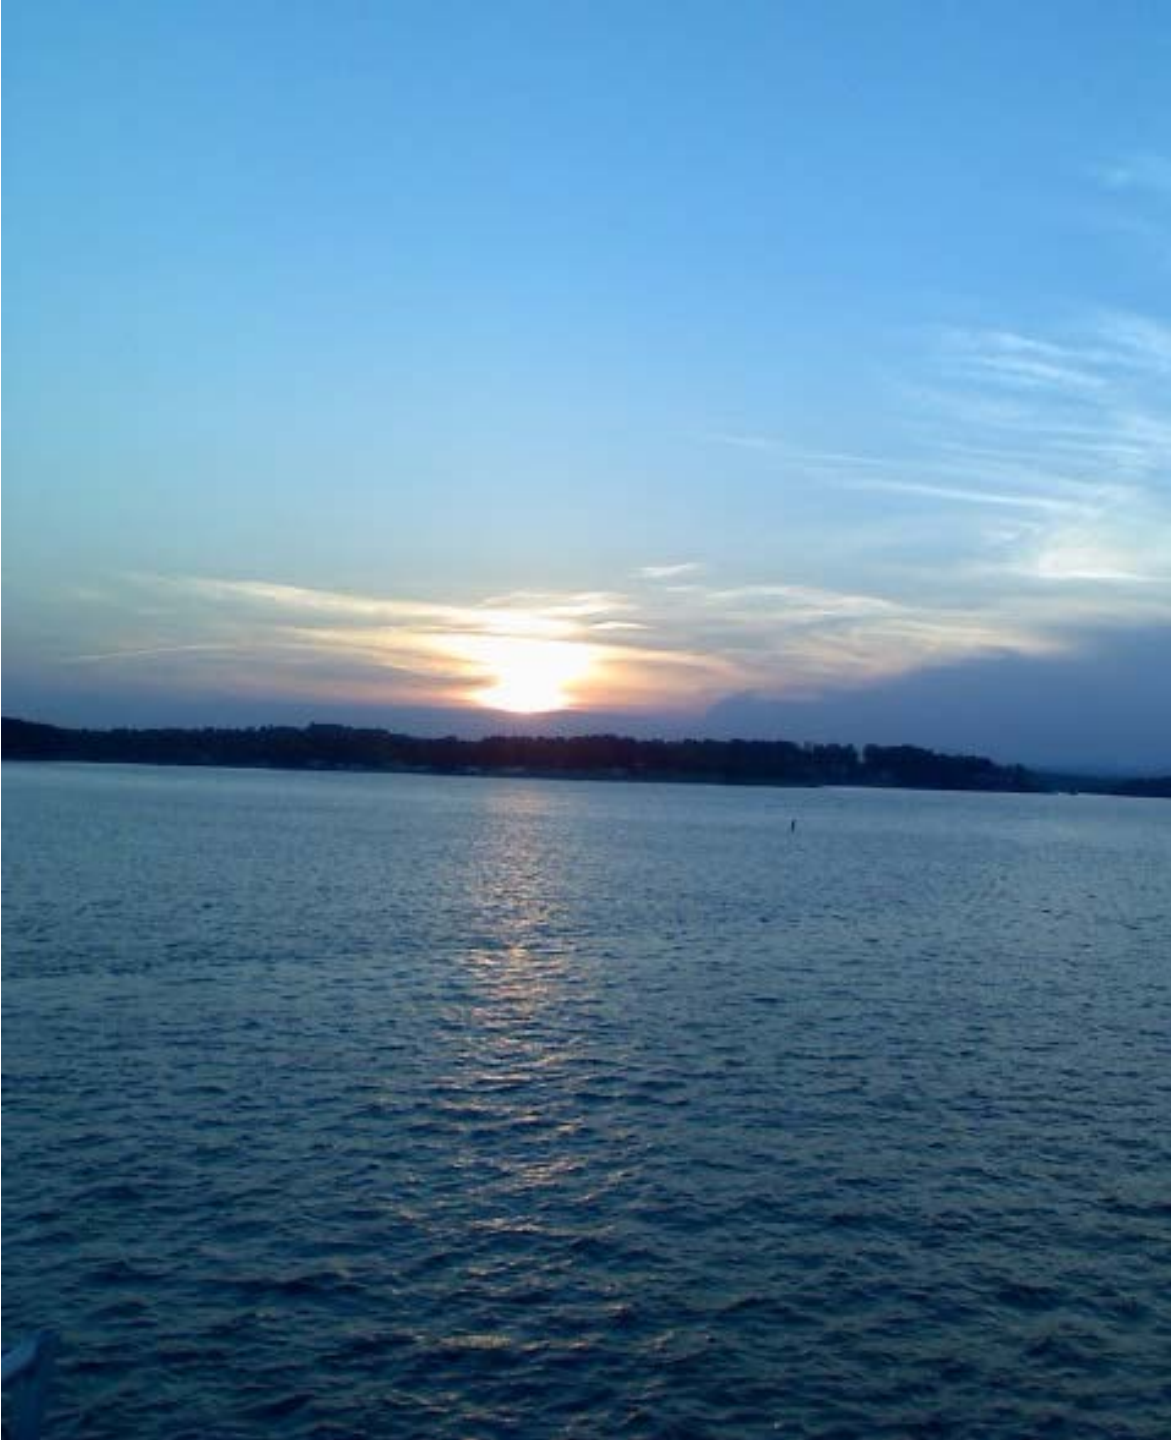
The ground movement is typically very slow moving and deep seated, often encompassing several acres of ground.

Uniquely, the surface profile of the moving areas is often rather flat, ranging from 3H:1V to 7H:1V, and the slides typically exit well below the lake surface

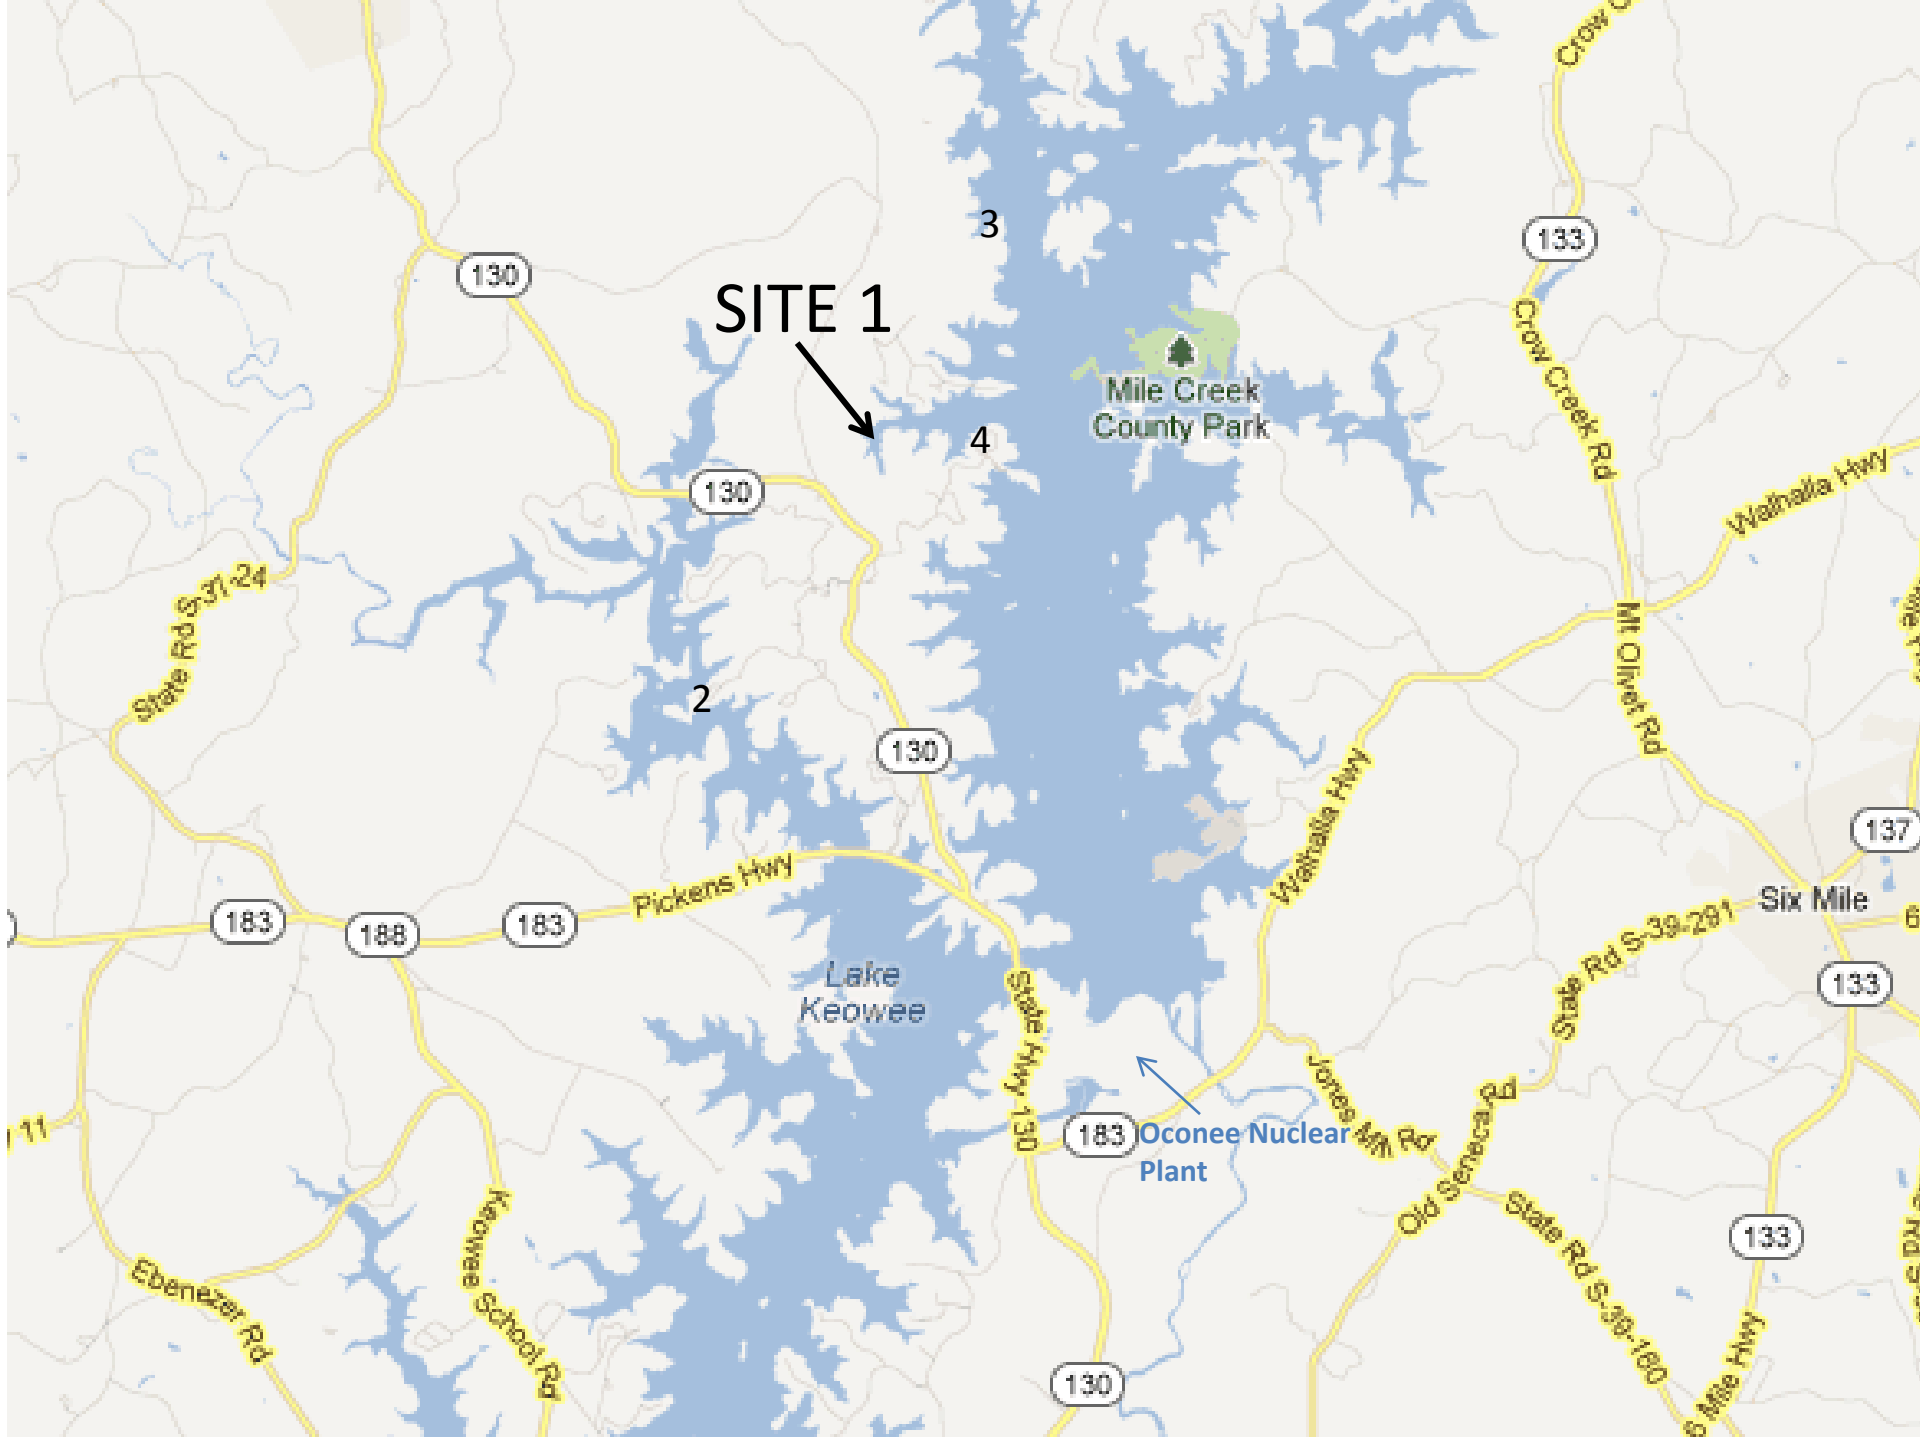
SITE 1

- Site 1 slide was repaired by others using patterned ground anchors.
- Slide was deep seated and extended into lake.
- Ground movement showed up as separation cracks in house.
- Ground was gently sloping.

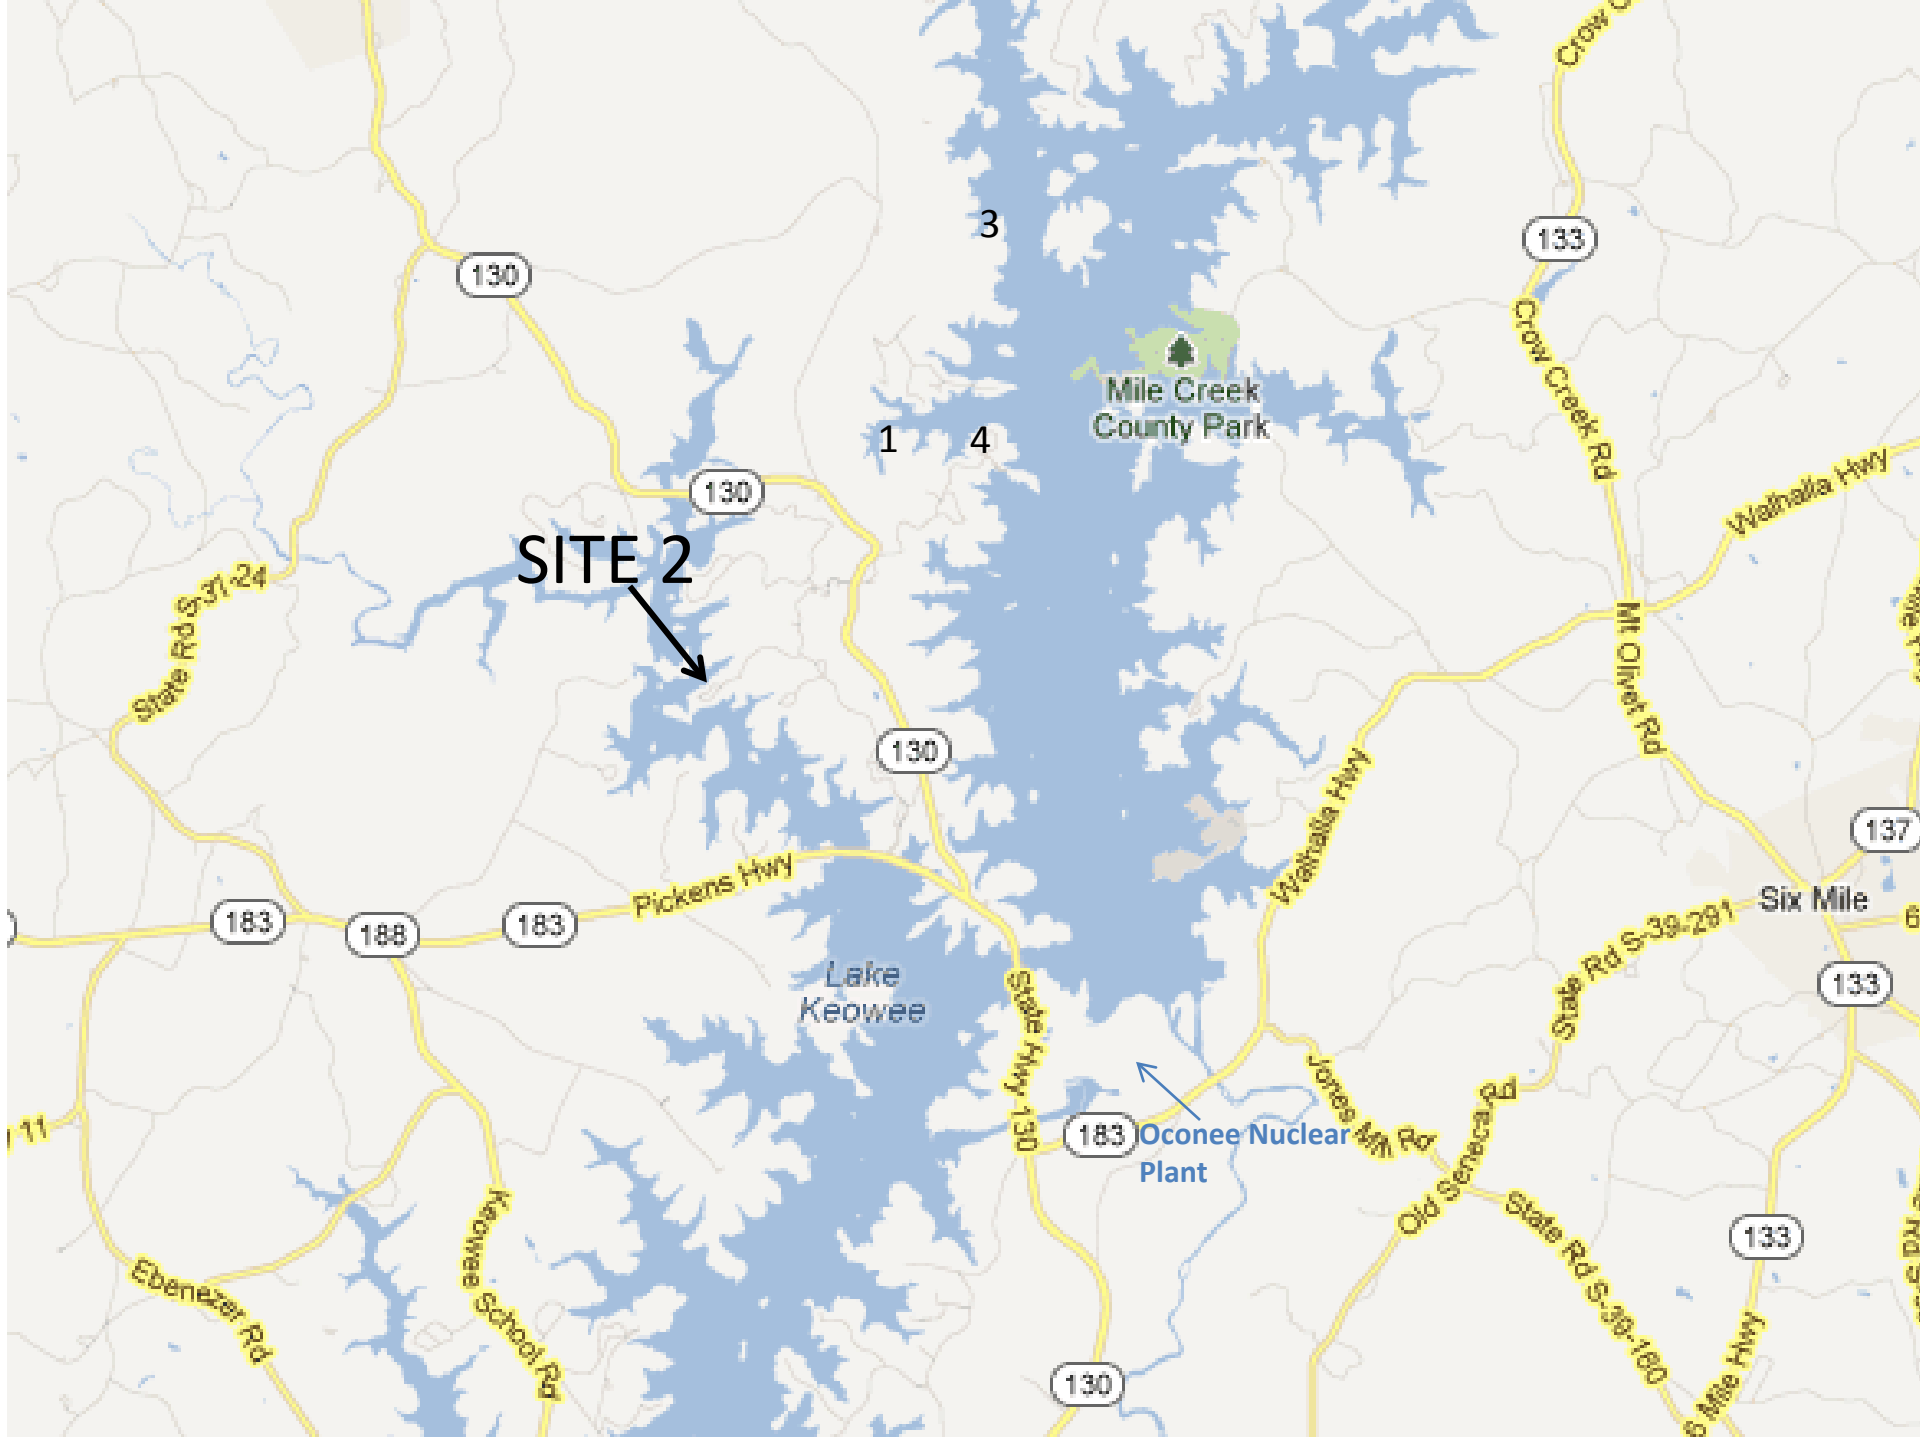
SITE 2

- Site 2 slide was repaired by others by regrading slope.
- Effectiveness of repair unknown.
- Slide was deep seated and extended into lake.
- Ground movement did not extend as far as house.
- Ground was moderately sloping.
- Slide is the edge of a larger slide that encompasses most of the adjacent lot and a third lot.
- Adjacent lot was abandoned.
- The third lot has a house on it and repairs were reportedly made by regrading the lot.

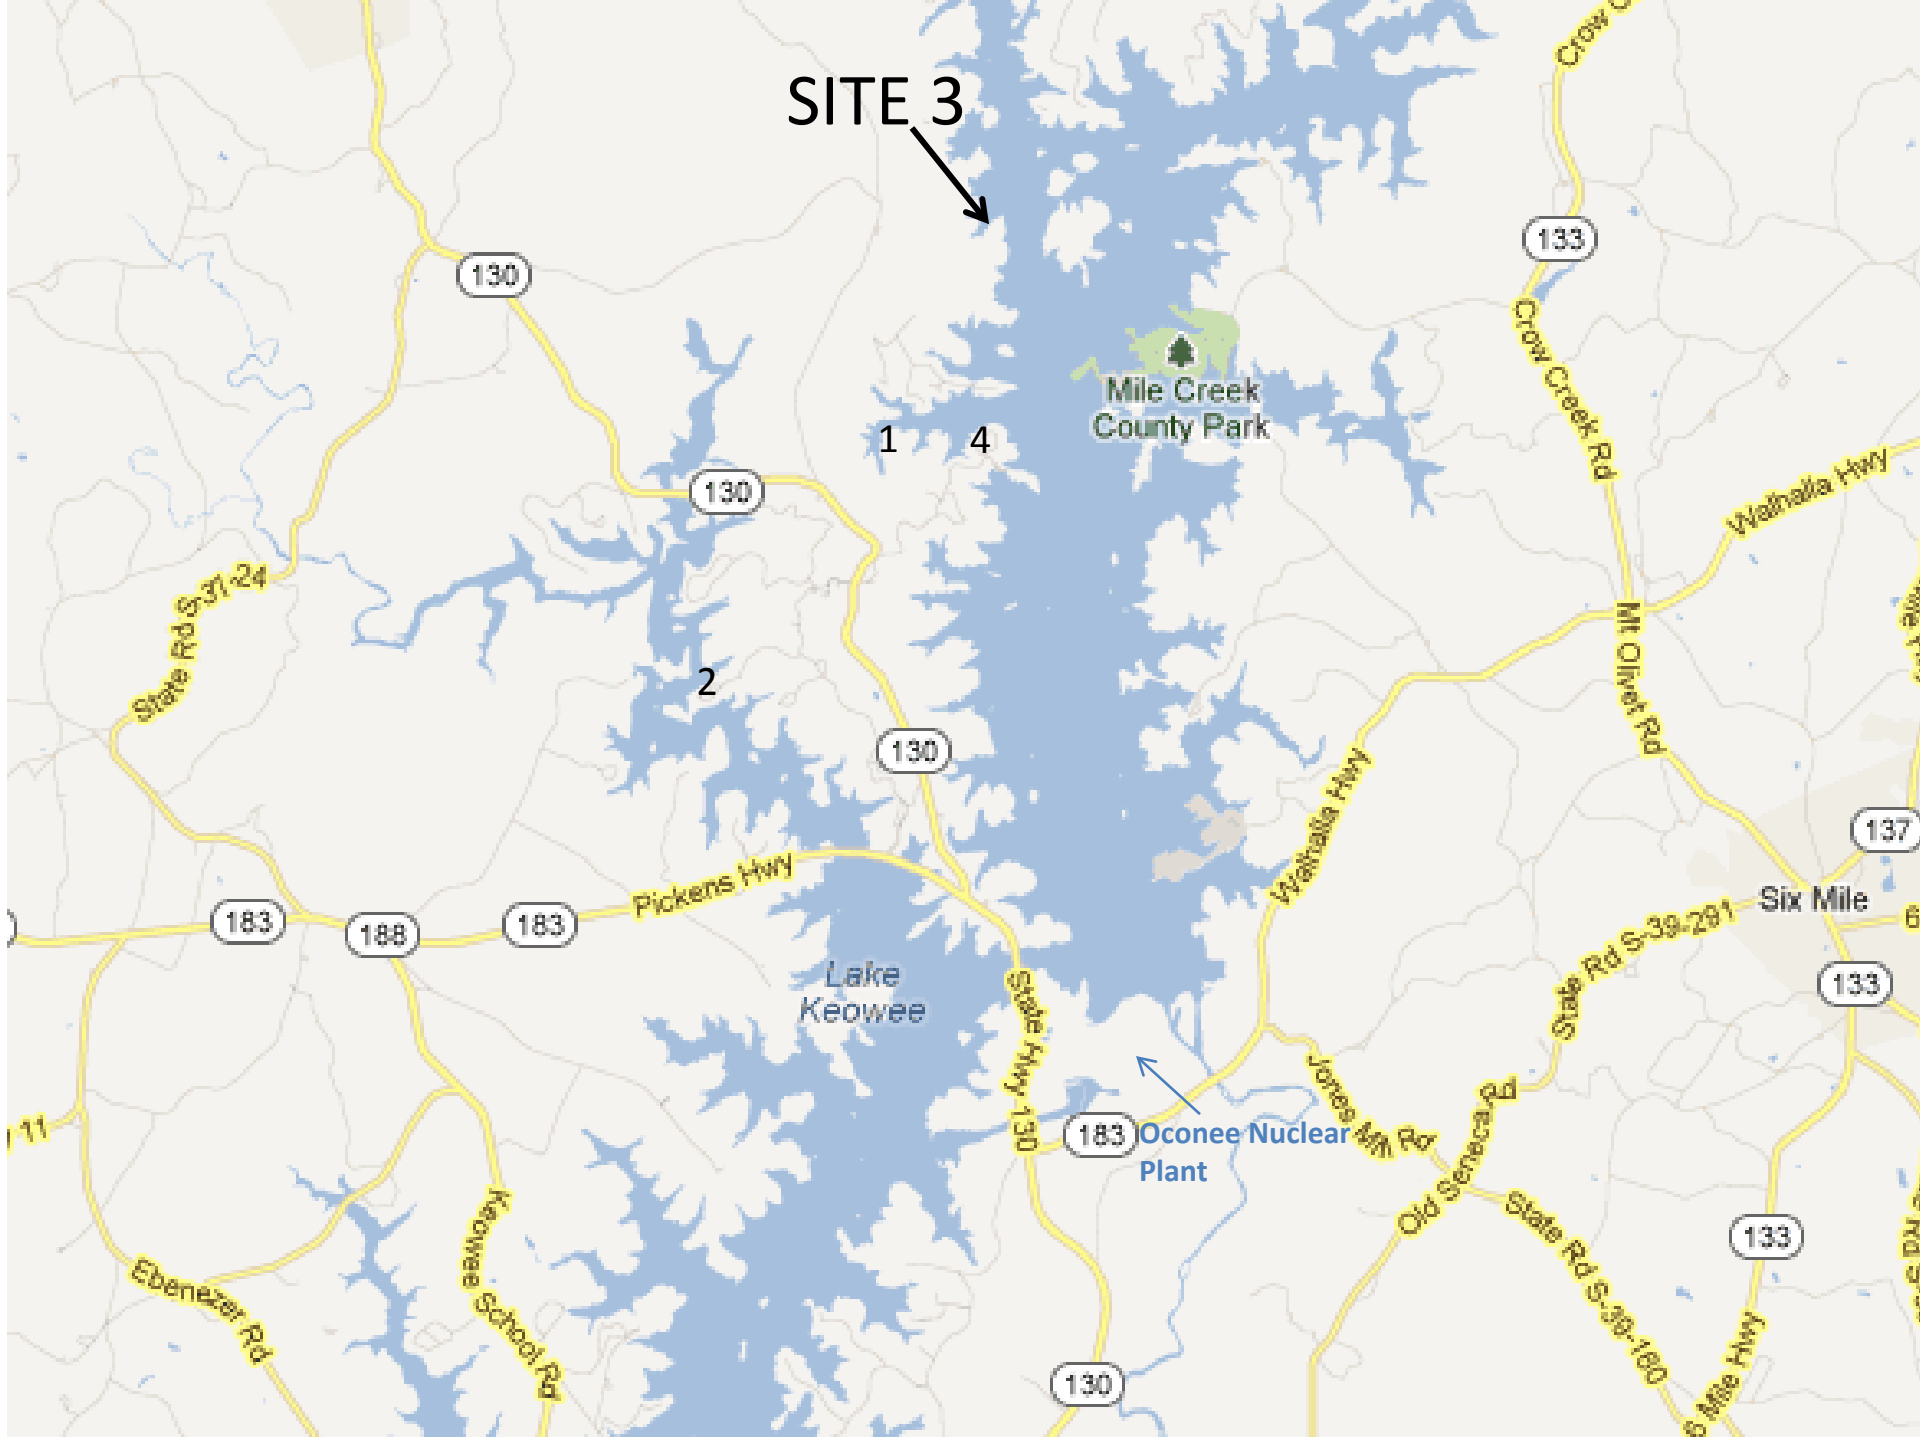
SITE 3

- Site 3 slide has not been repaired at this time.
- Slide is deep seated and extends into lake.
- Ground movement showed up as small to large tension cracks.
- Large tension cracks at first appear to be ditches and old roads.
- Ground was gently sloping (ie 6H:1V), however, ground offshore is as steep as 1H:1V.
- Initial repairs were made by others to a new house located in the middle of the slide area included helical piers. Piers could be tightened up, then would loose. WEC was then asked to look at site.
