# Emergency Response to Rockfall on Tennessee's Interstate 75

Presentation By: J. Reid Bailey, PE  
GeoStabilization International  
[reid@gsi.us](mailto:reid@gsi.us)

# I-75 MP 142.5 prior to February 26, 2016

# Failure onto I-75

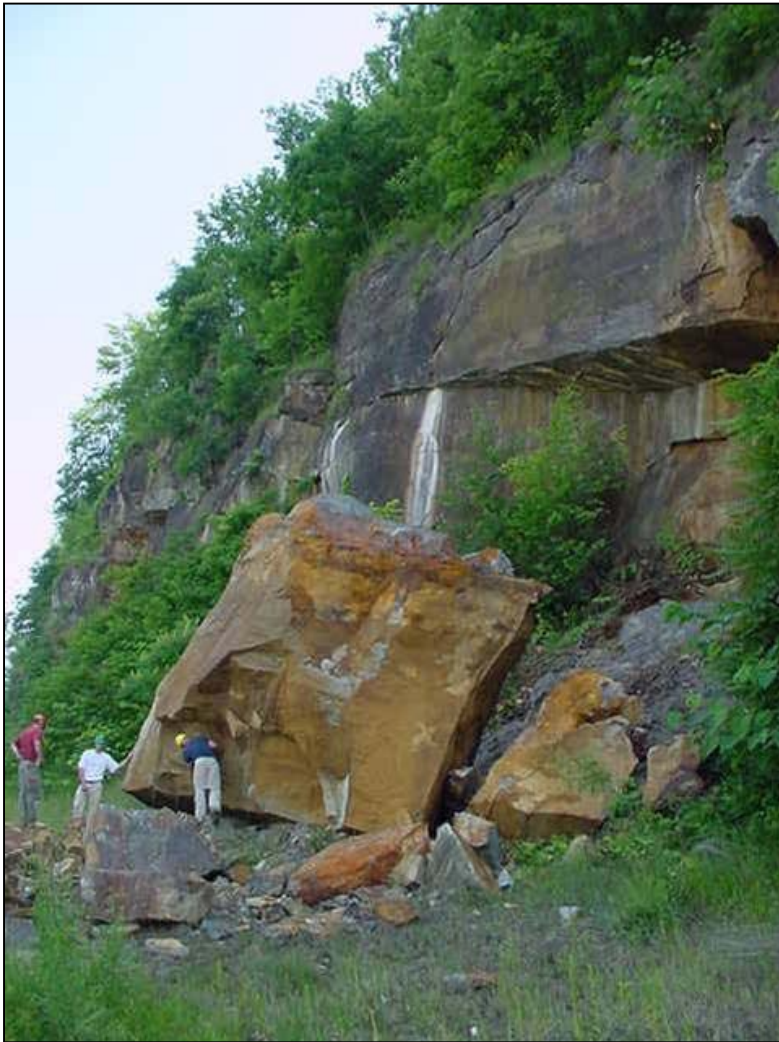
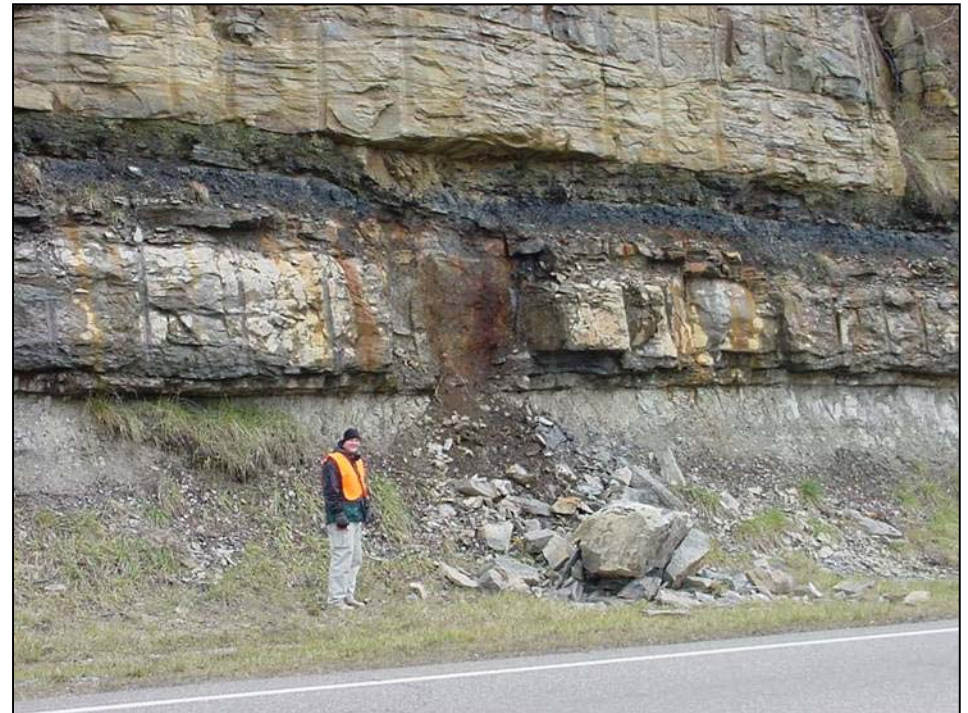
# Local Failures with Valley Stress Relief Joints

Less durable units can erode quicker than more durable units creating overhangs. As erosion continues towards the VSRJ rockfalls can occur

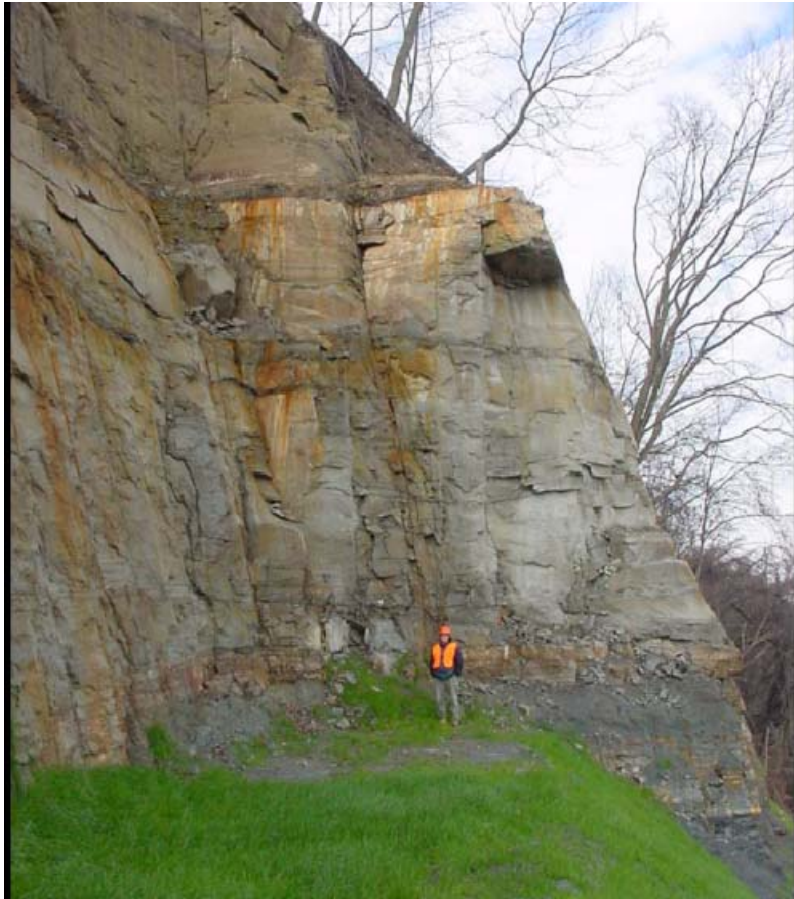
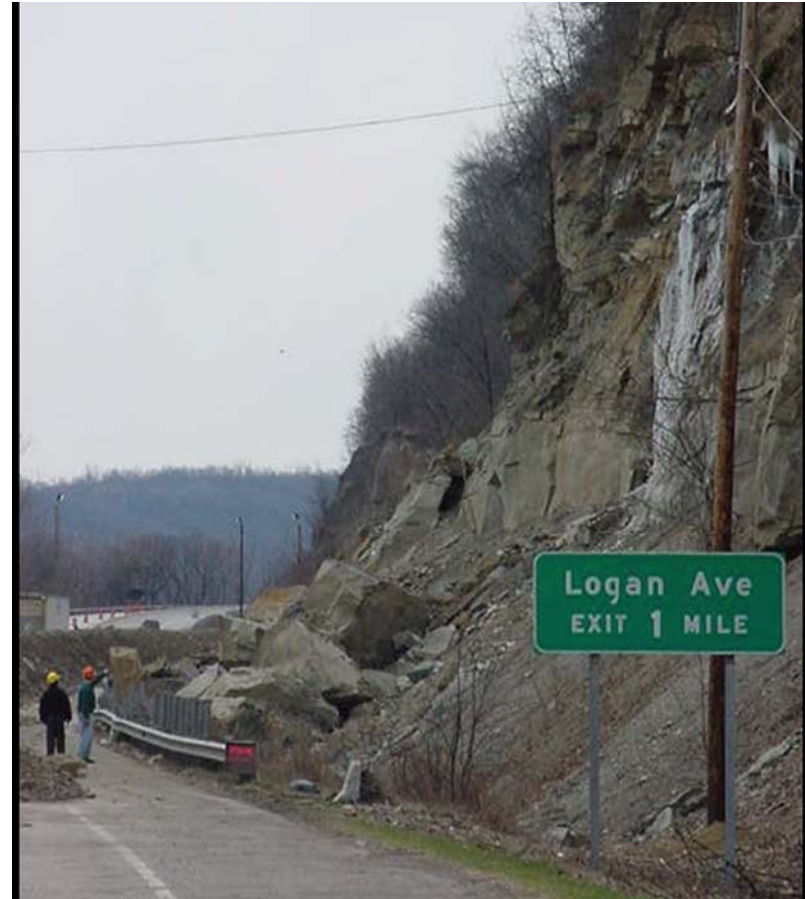
# Large Failures Caused By Valley Stress Relief Joints (VSRJ)

Some slopes can fail along the VSRJ if undercutting or pressures are high enough

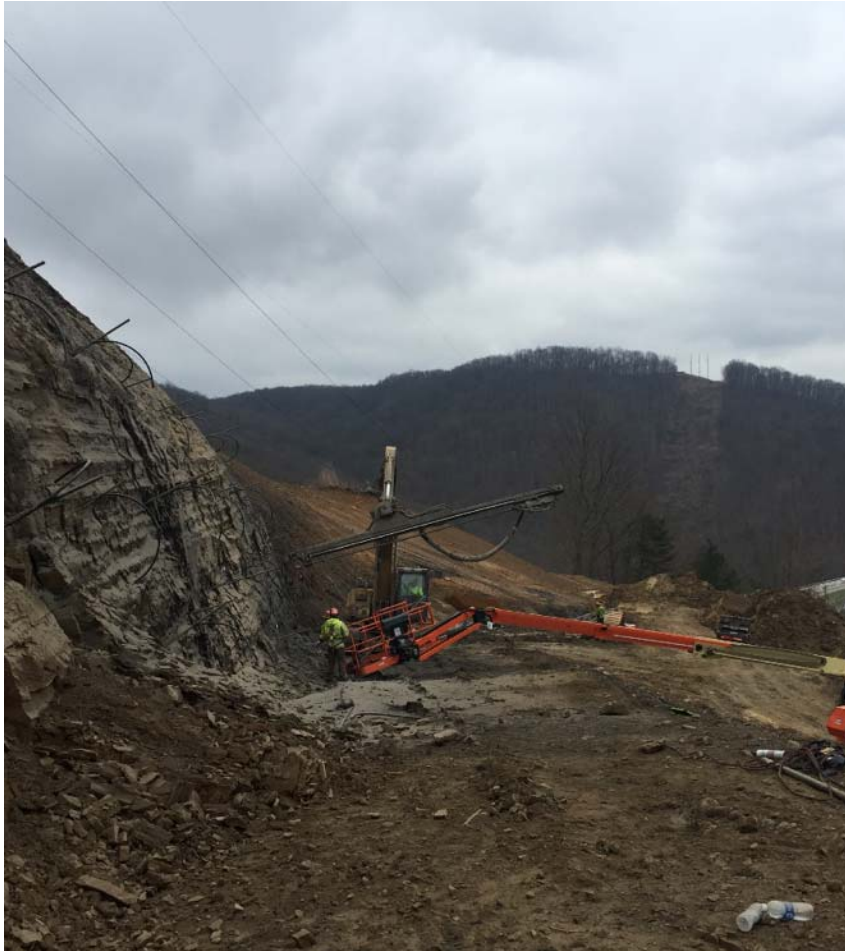
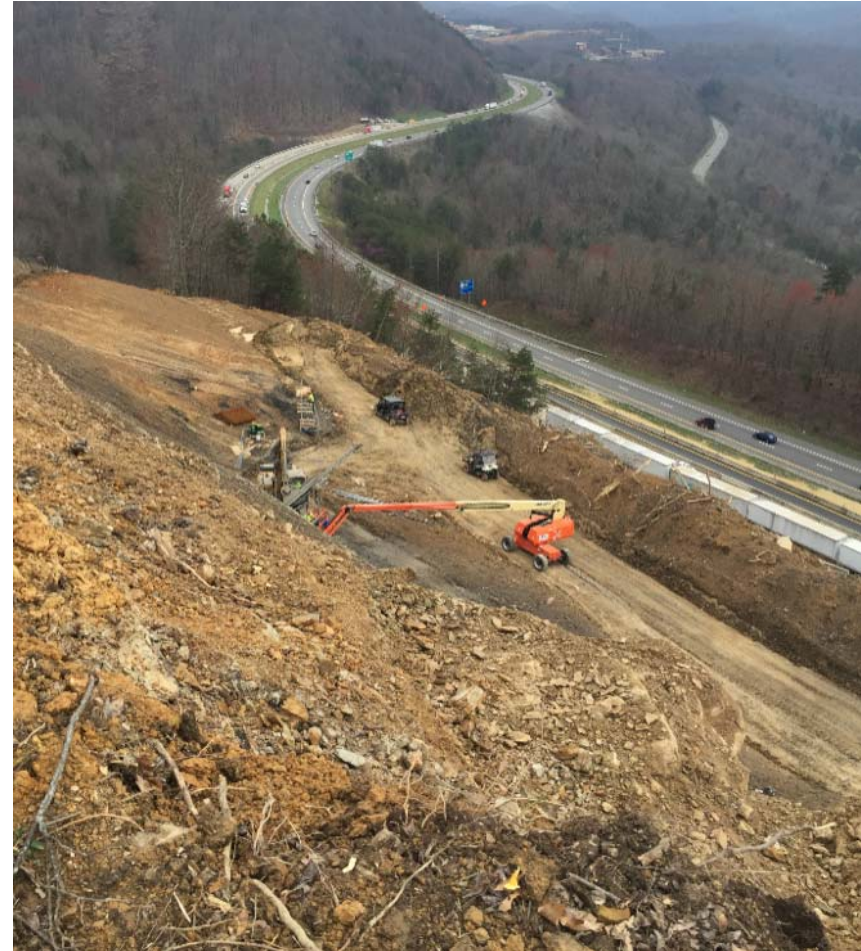
# Excavation and Preparation of Vertical Feature

- During excavation vertical structure noticed in middle of slope
- All failed material in front
- Can't continue 1H: 1V slope
- Valley Stress Relief Joint

- Left with a vertical feature with a 1H:1V Slope above
- GeoBrugg Tecco G65 3mm - Pinned Mesh on 1H:1V Slope above
- Vertical Cut - Shotcrete Surface Protection – VSRJ Area
