Steeper is Cheaper, "Danger Falling Rocks!"

Geohazards Impacting Transportation in Appalachia 16th Annual Technical Forum Knoxville, Tennessee August 2016

Eric B. Rehwoldt, PE, PG Schnabel Engineering, Inc.

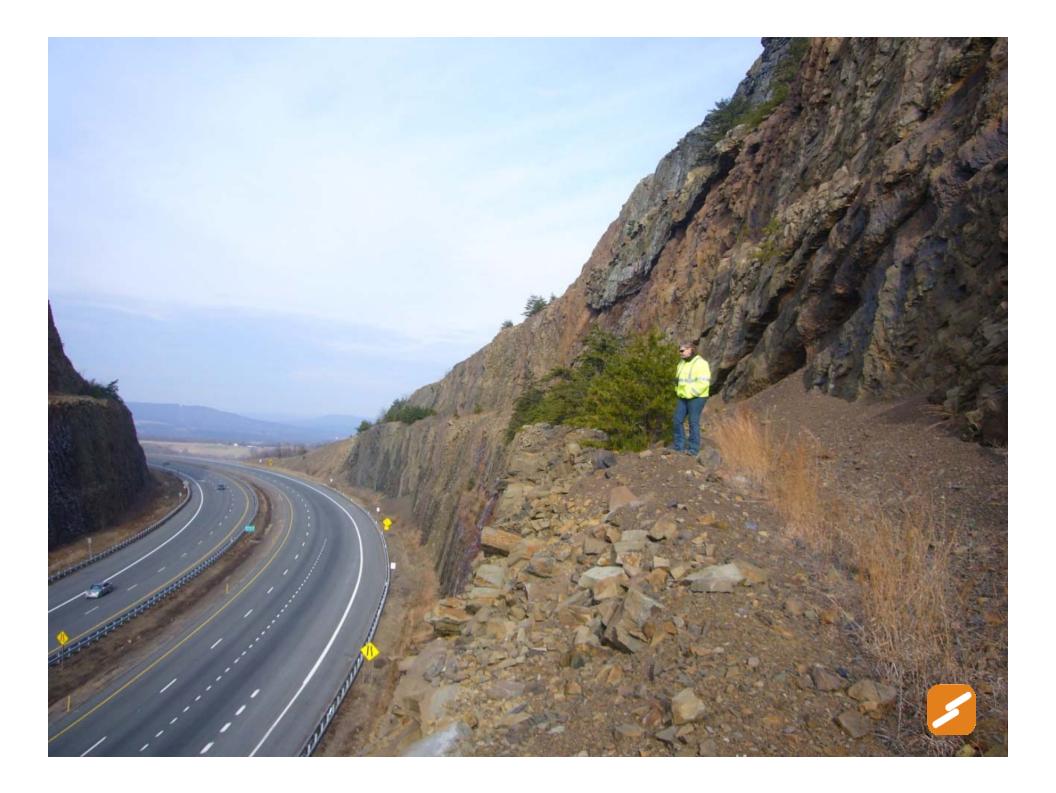
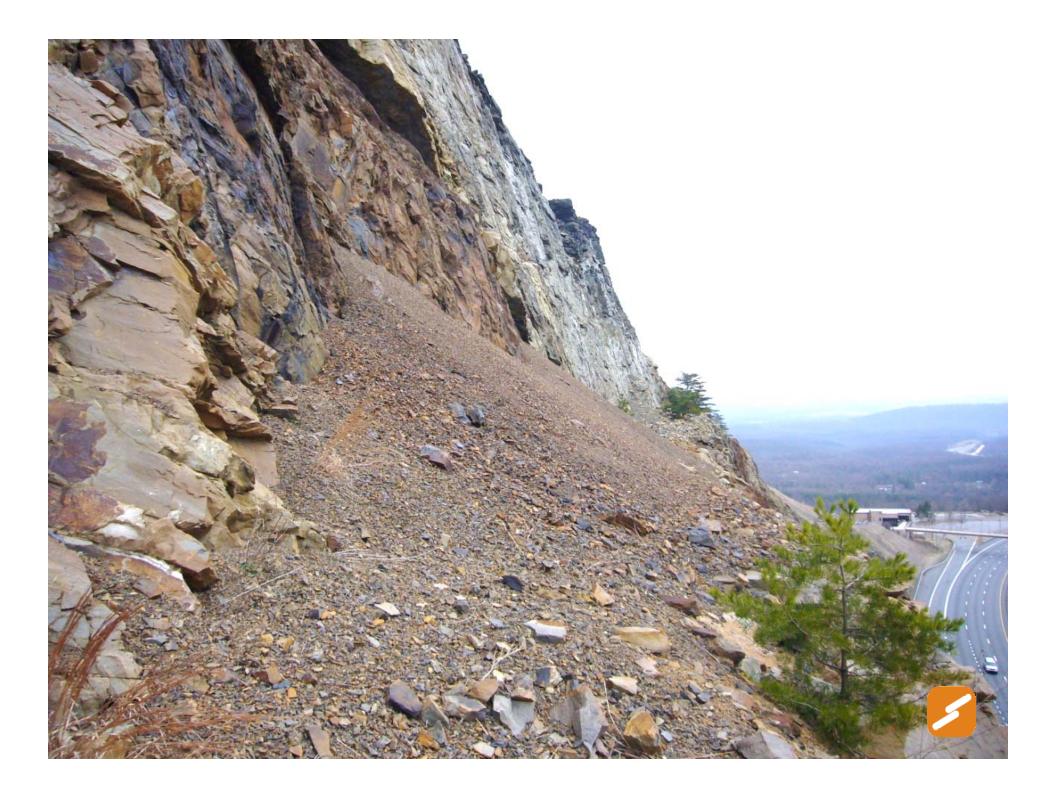
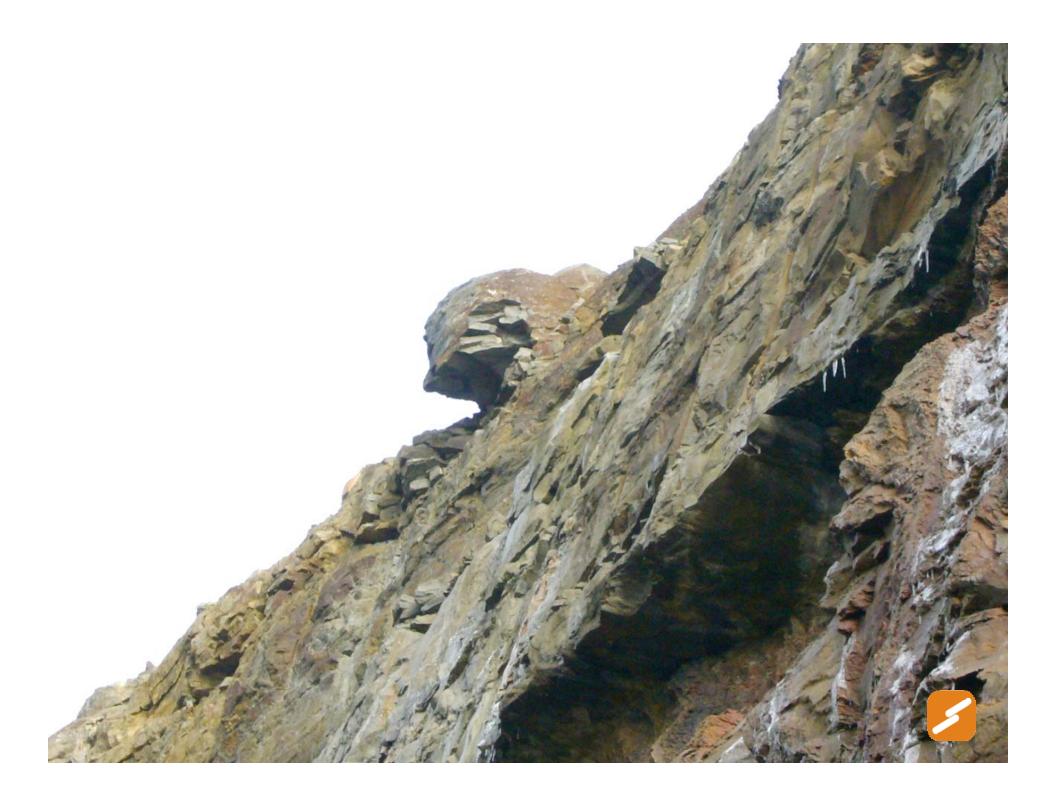
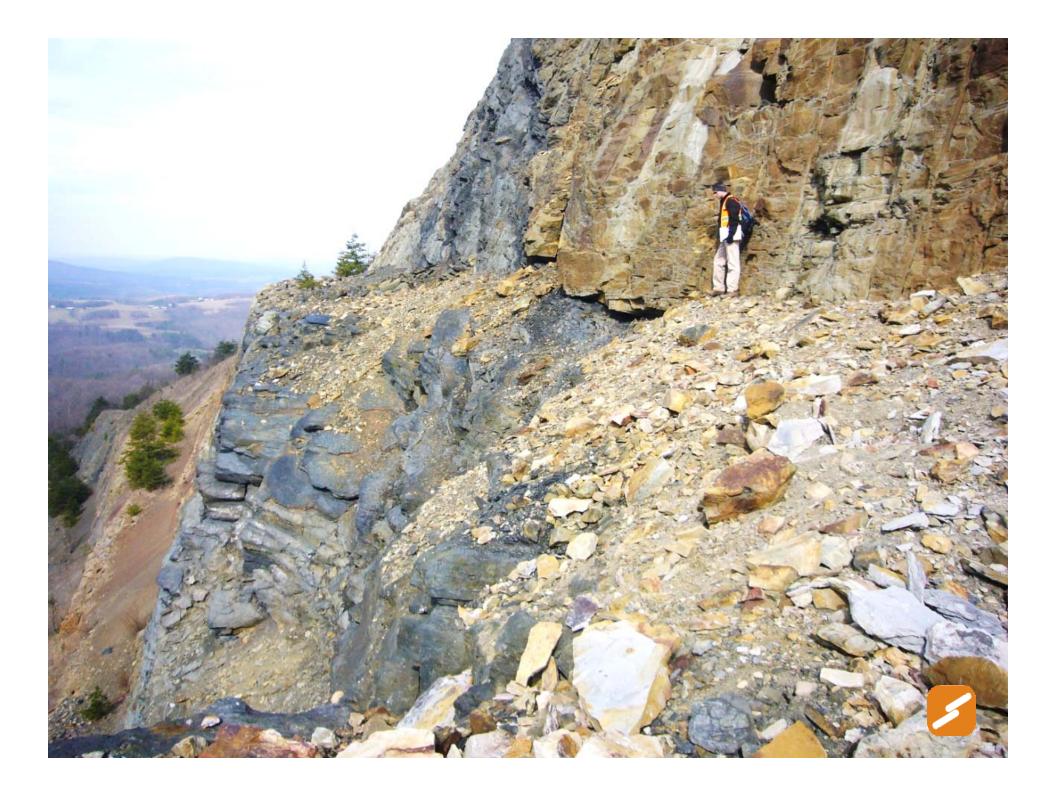
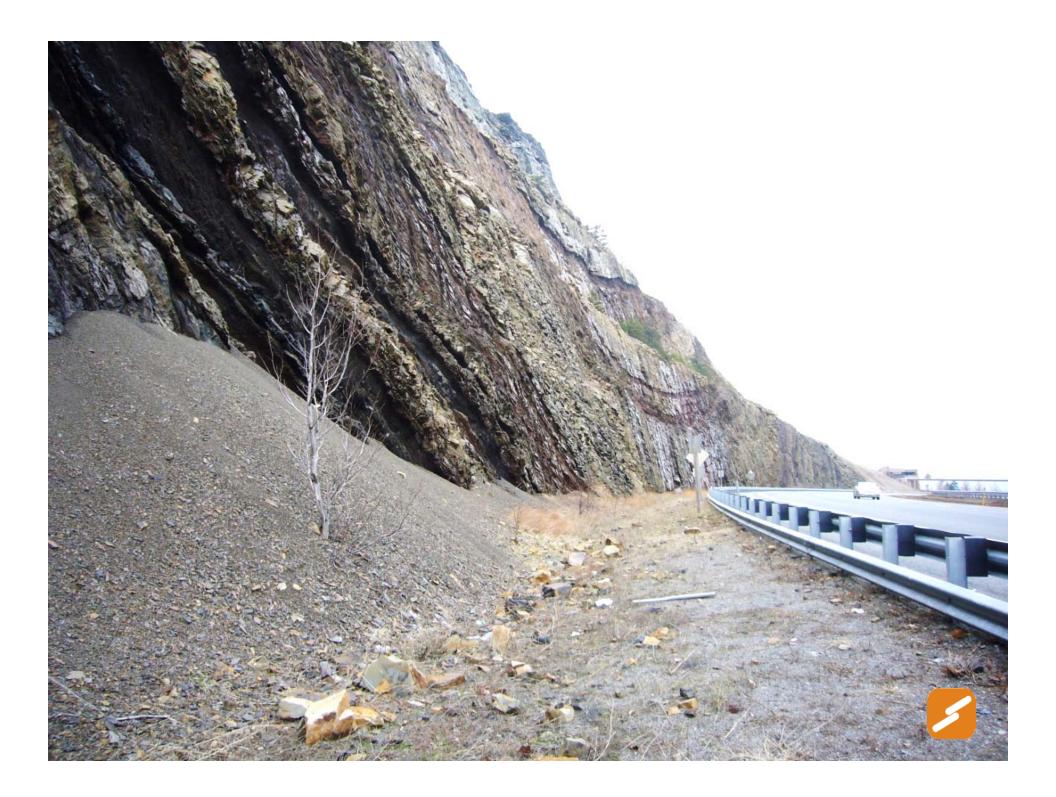
Deterioration of Benches & Rock Falls

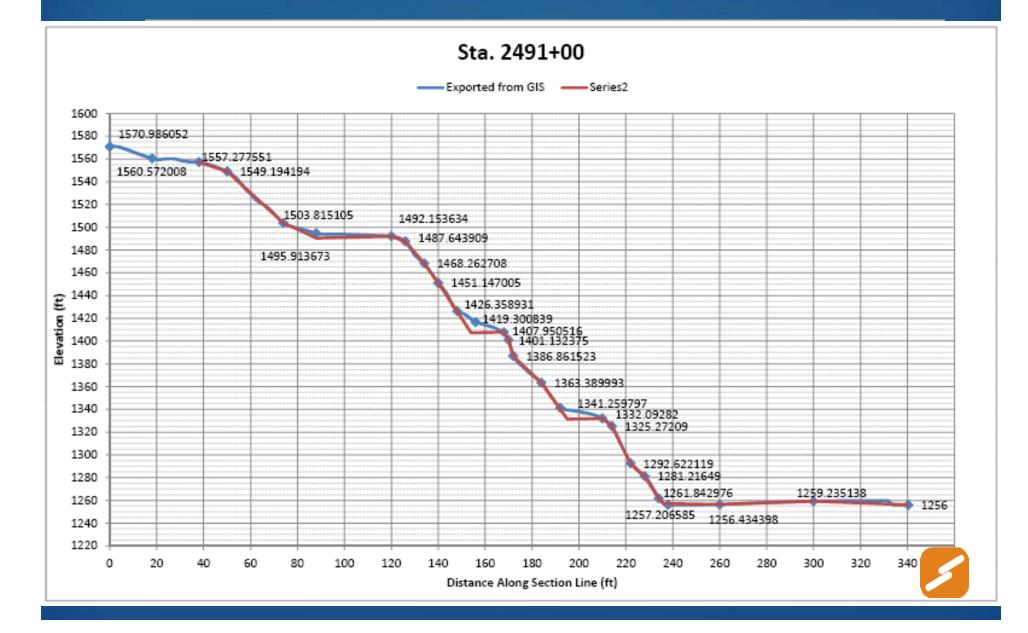
Rockfall Hazard Analysis

Conclusions from Hazard Study

- Emergency Action Not Required
- Bench-Scale Failures Not Indicated
- Small-Scale Rockfall Hazard
- Inadequate Catchment
- Debris Wedges
- Marginally-Stable Rock Blocks
- Overhanging Rock Ledges
- Vegetation

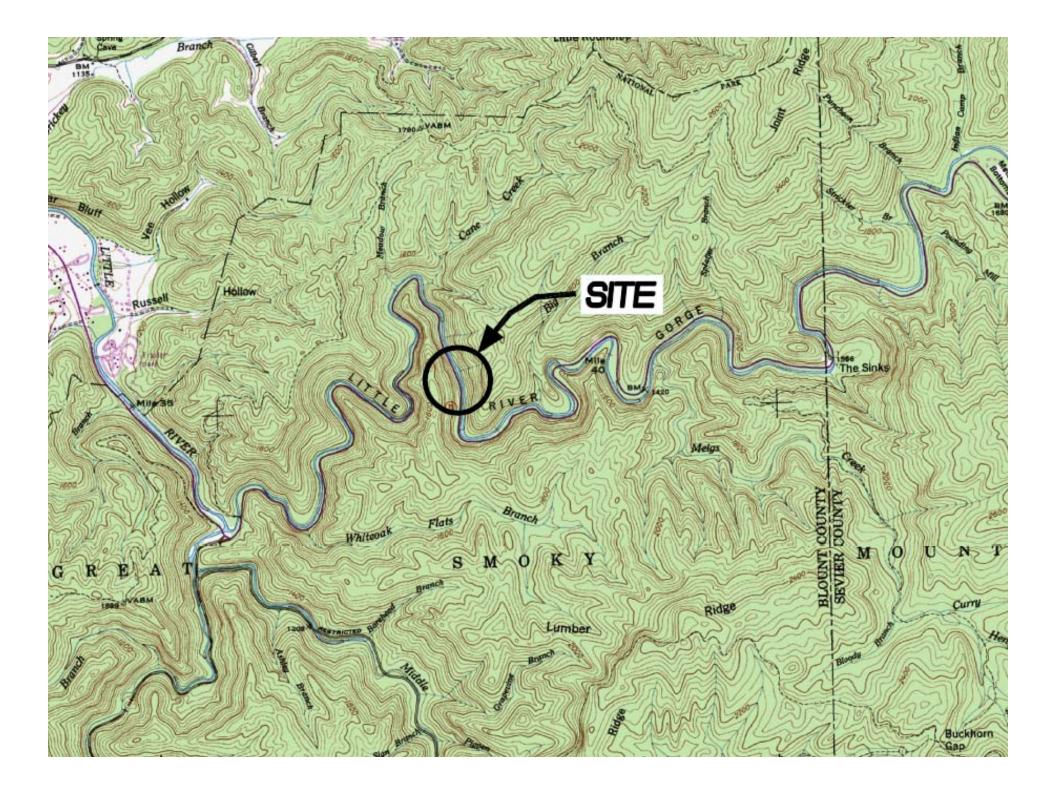
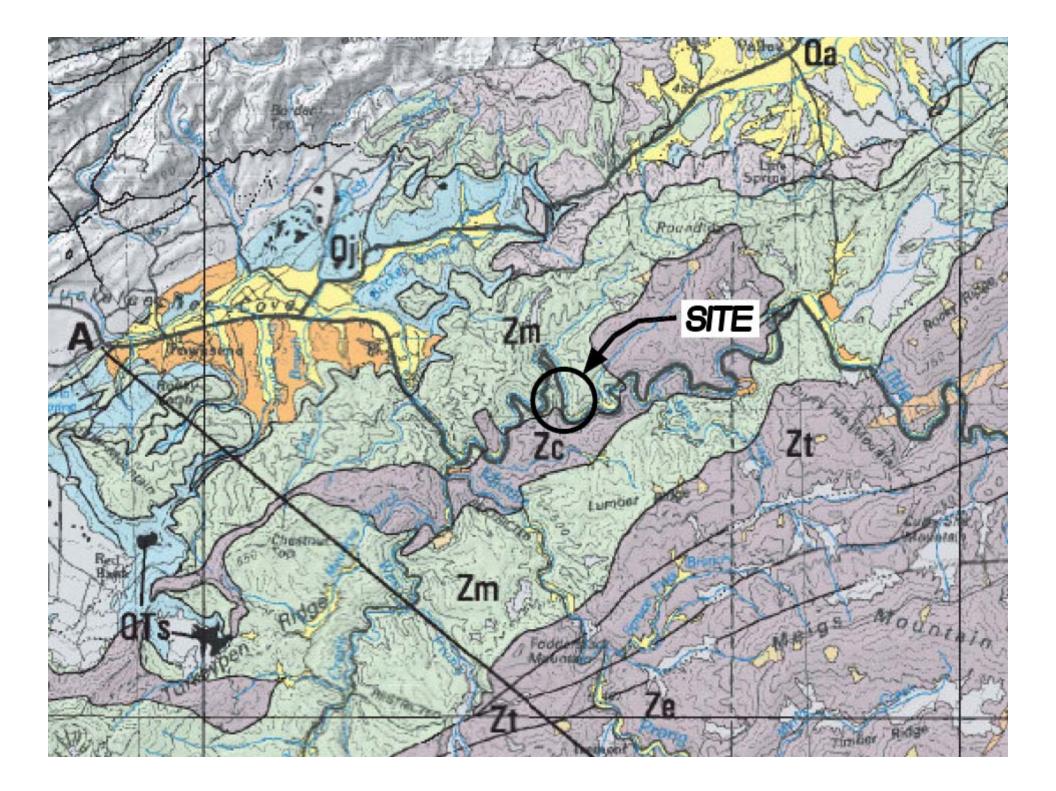
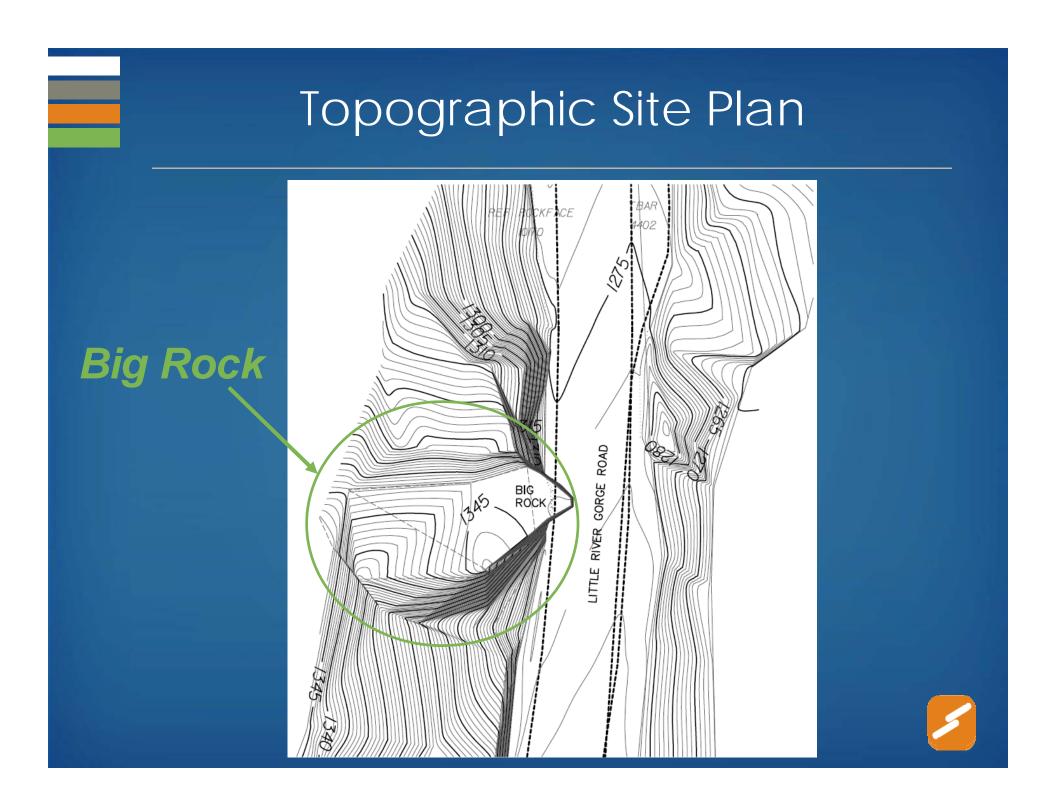
Response to Large Rock Fall from 'Big Rock'

Up to 7 ft. rock slabs on Little River Gorge Road During Storm

Provide Assessment and Concept Remedial Design
