# Interstate 20 Improvements near Birmingham, Alabama. A Case History in Innovative Teamwork, Project Safety and Final Results

Steven Wright, President, Wright Bros. Construction
Daniel Conn, President, Kesco Fragmentation Efficiency Services
Peter Ingraham, Principal, Golder Associates Inc.

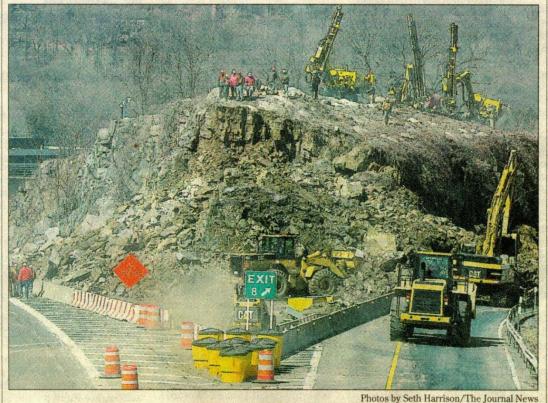
## I-287/87 rebuilding begins

Photos by Seth Harrison/The Journal News New York State Thruway Authority crews clean up crushed rock and debris yesterday on Interstate 87 at the Interstate 287 split after the first round of rock blasting in a major exit renovation project.

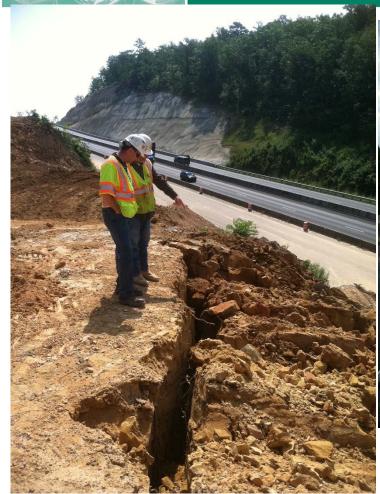
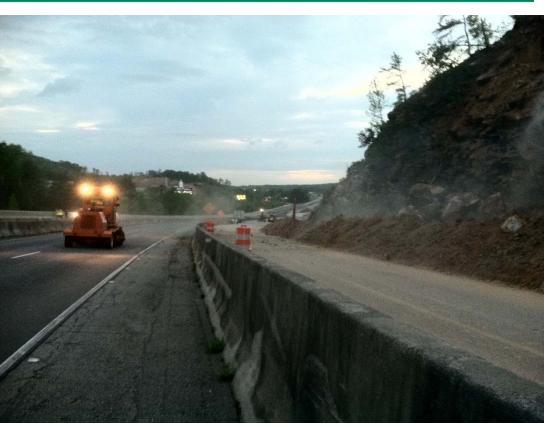
#### Staging Construction – Constructing Eastbound Side First to Make room

- Staging Construction Constructing Eastbound side first to make room
- Adjusting slope angles to be shallower than geologic features.
- Shifting traffic to the new median to provide catchment at the toe of the westbound slopes
- Blasting at night when traffic was least intense (least impact to stakeholders) you need a thinking blaster, not the cheapest.....
- Be prepared for a slow wedge failure with room and equipment for rapid clean up.

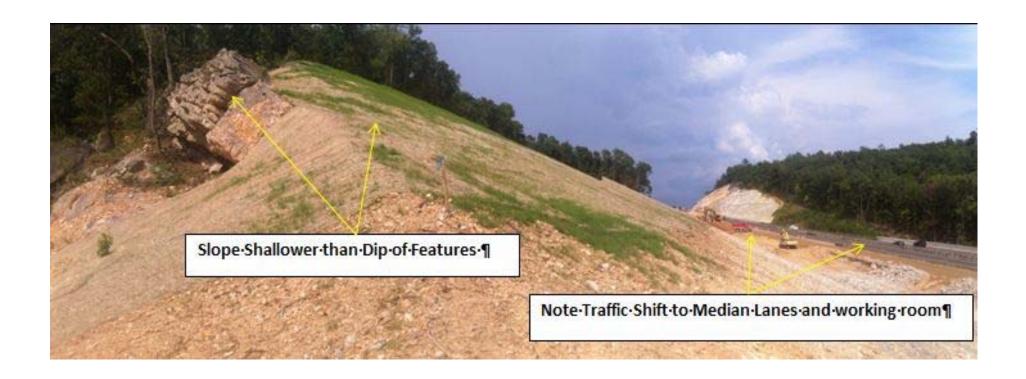
Adjusting slope angles to be shallower than geologic features.

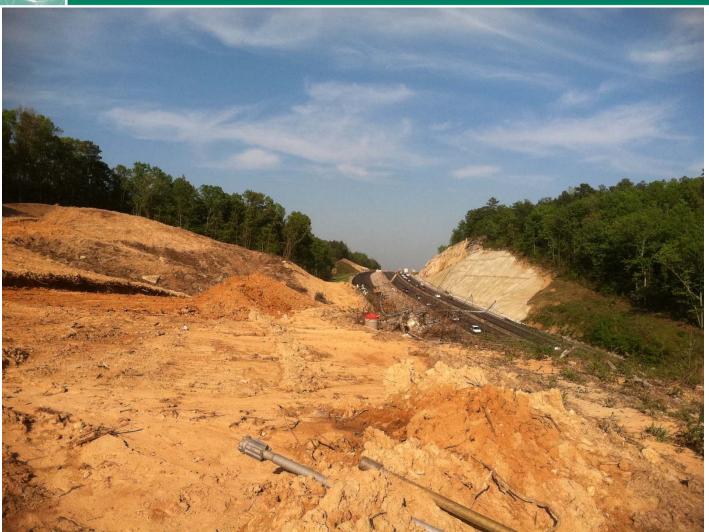
## Shifting traffic to the new median to provide catchment at the toe of the westbound slopes

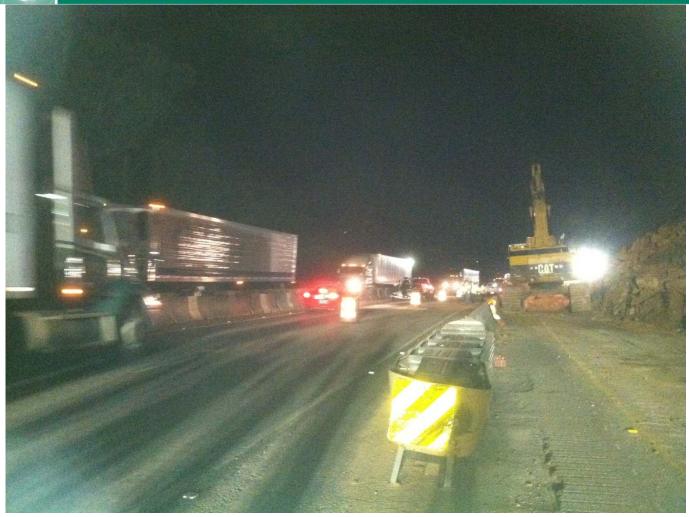
#### Blasting at night when traffic was least intense (least impact to stakeholders)

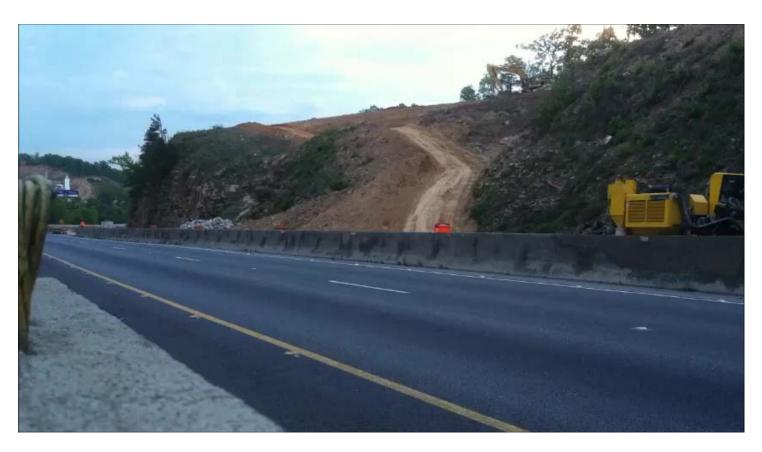
#### Be prepared for the slow wedge failure with room for catchment

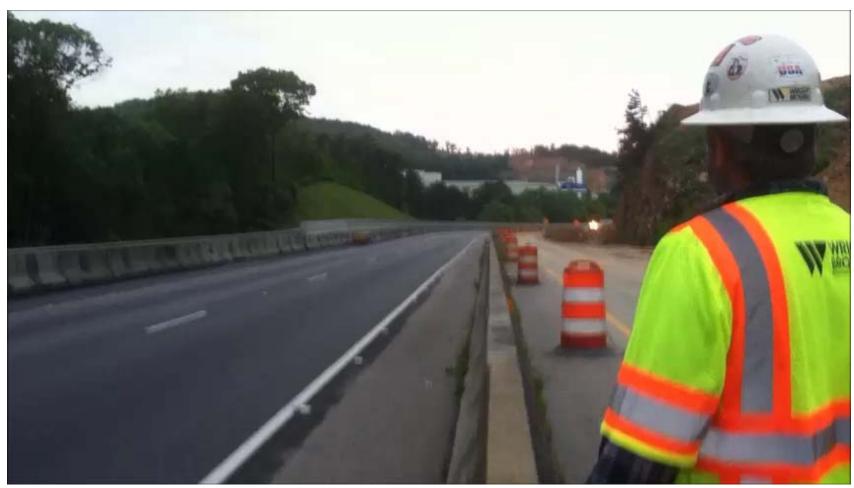
#### Be prepared for the slow wedge failure with room for catchment

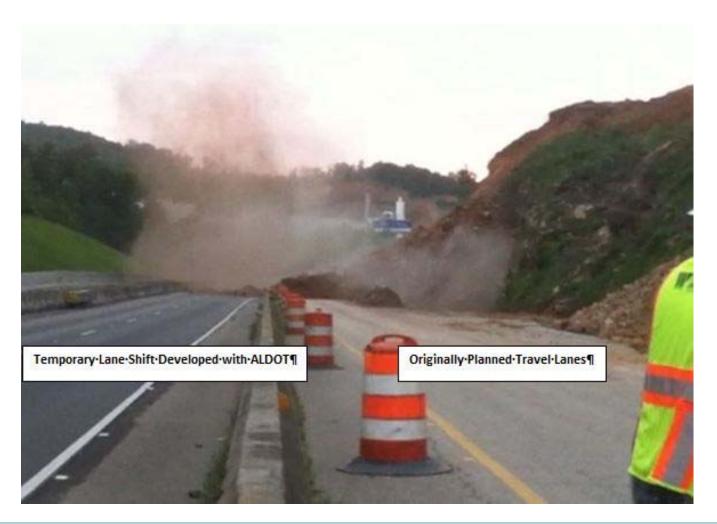
#### What was going to happen, happened – without result
