# Lessons Learned in the Repair of Failed Walls

Nate Beard

# Mechanically Stabilized Earth (MSE) Wall Failures

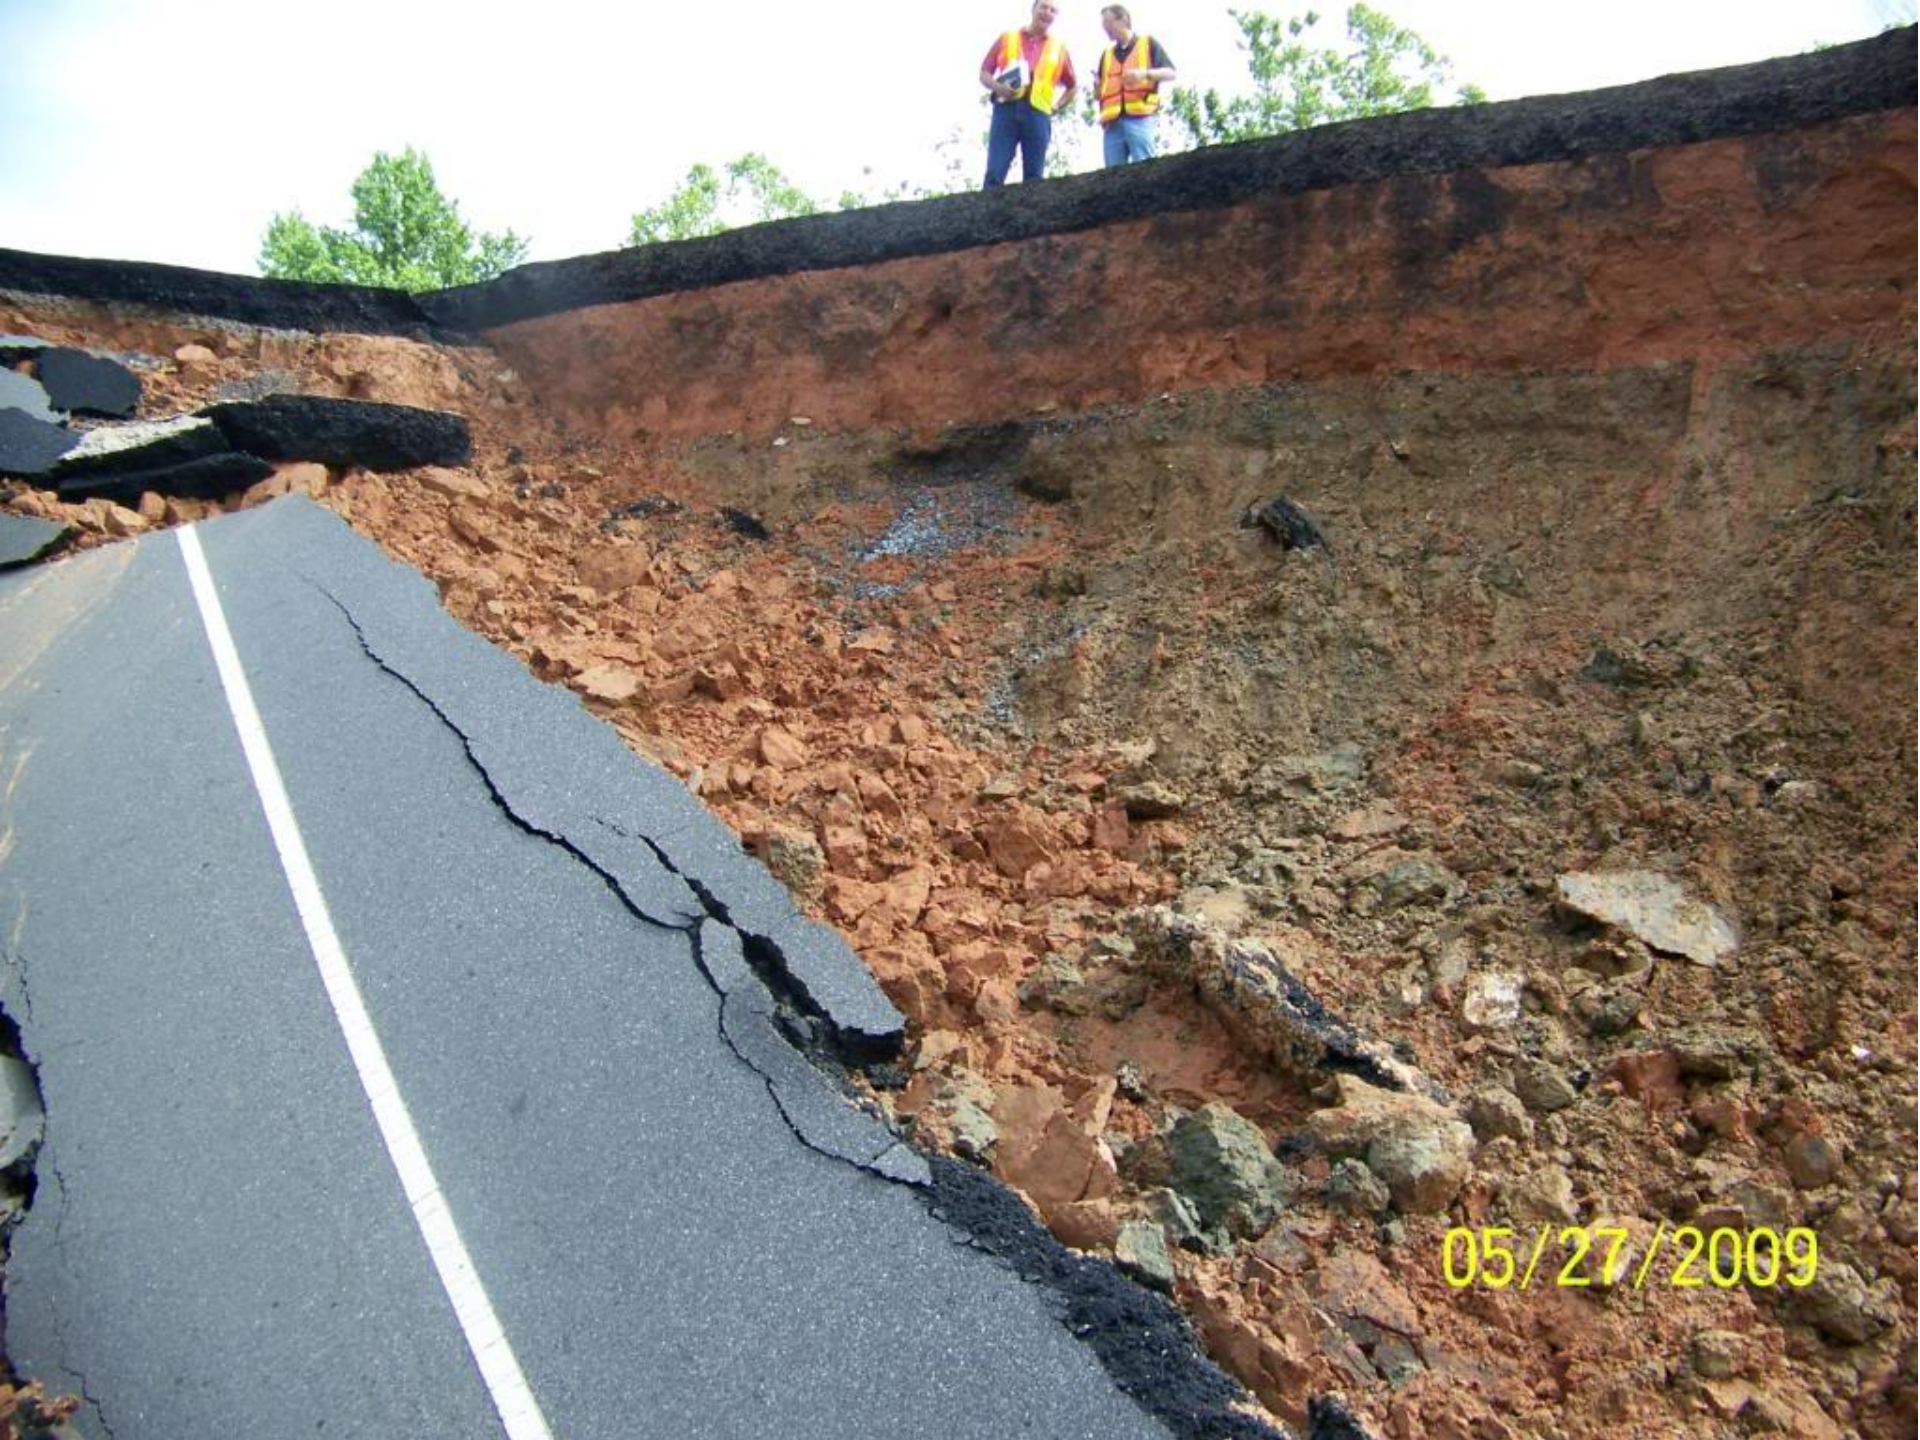
05/27/2009

SNLI Representatives were on site the following morning to assess the damage.

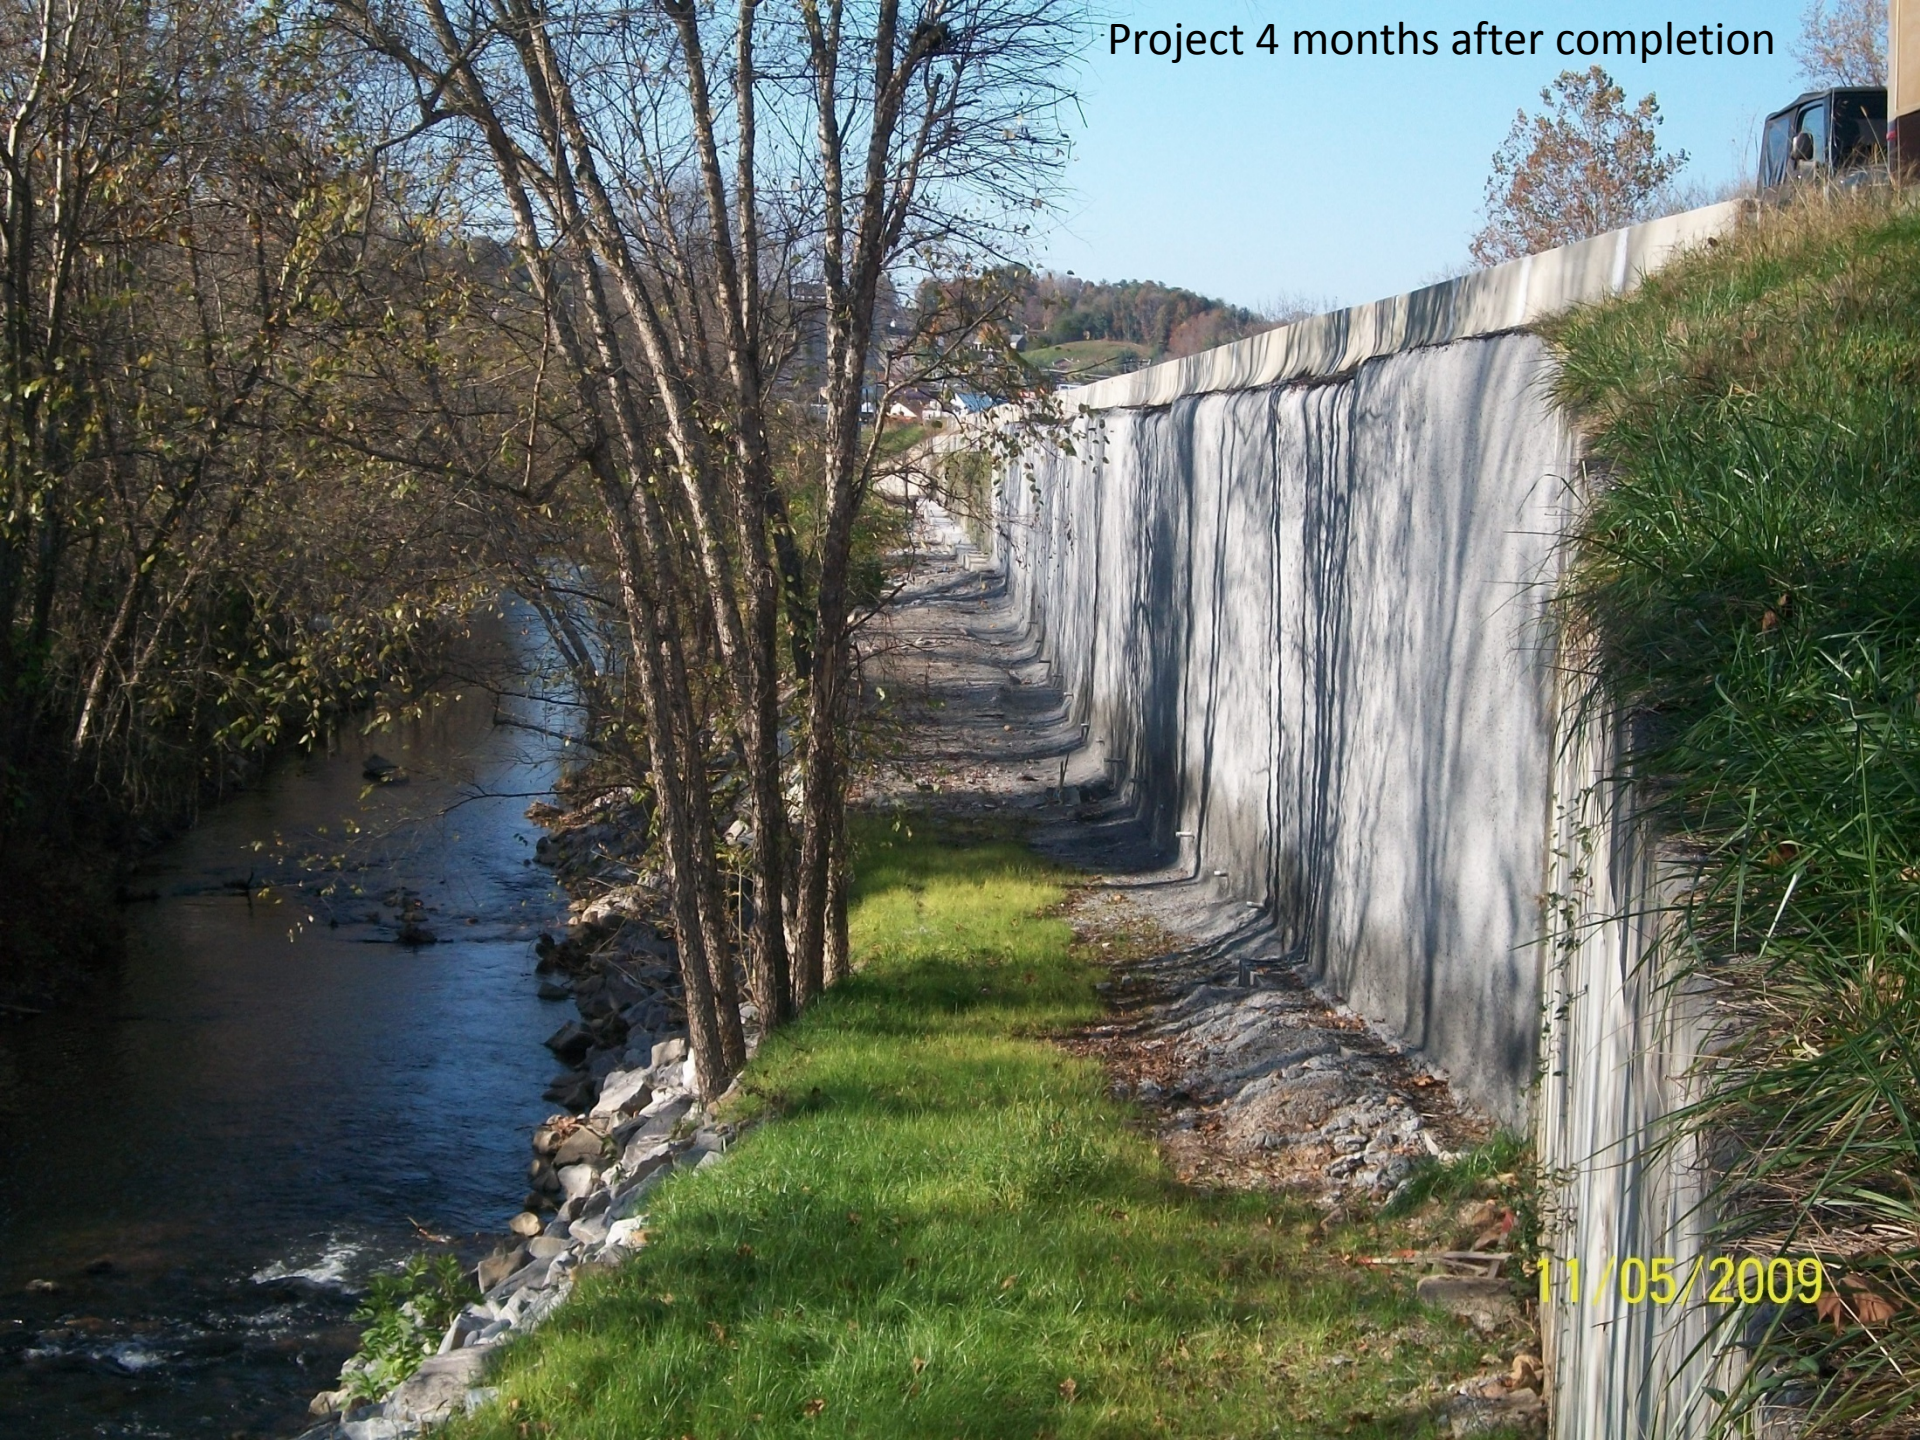
11/05/2009

Project 4 months after completion

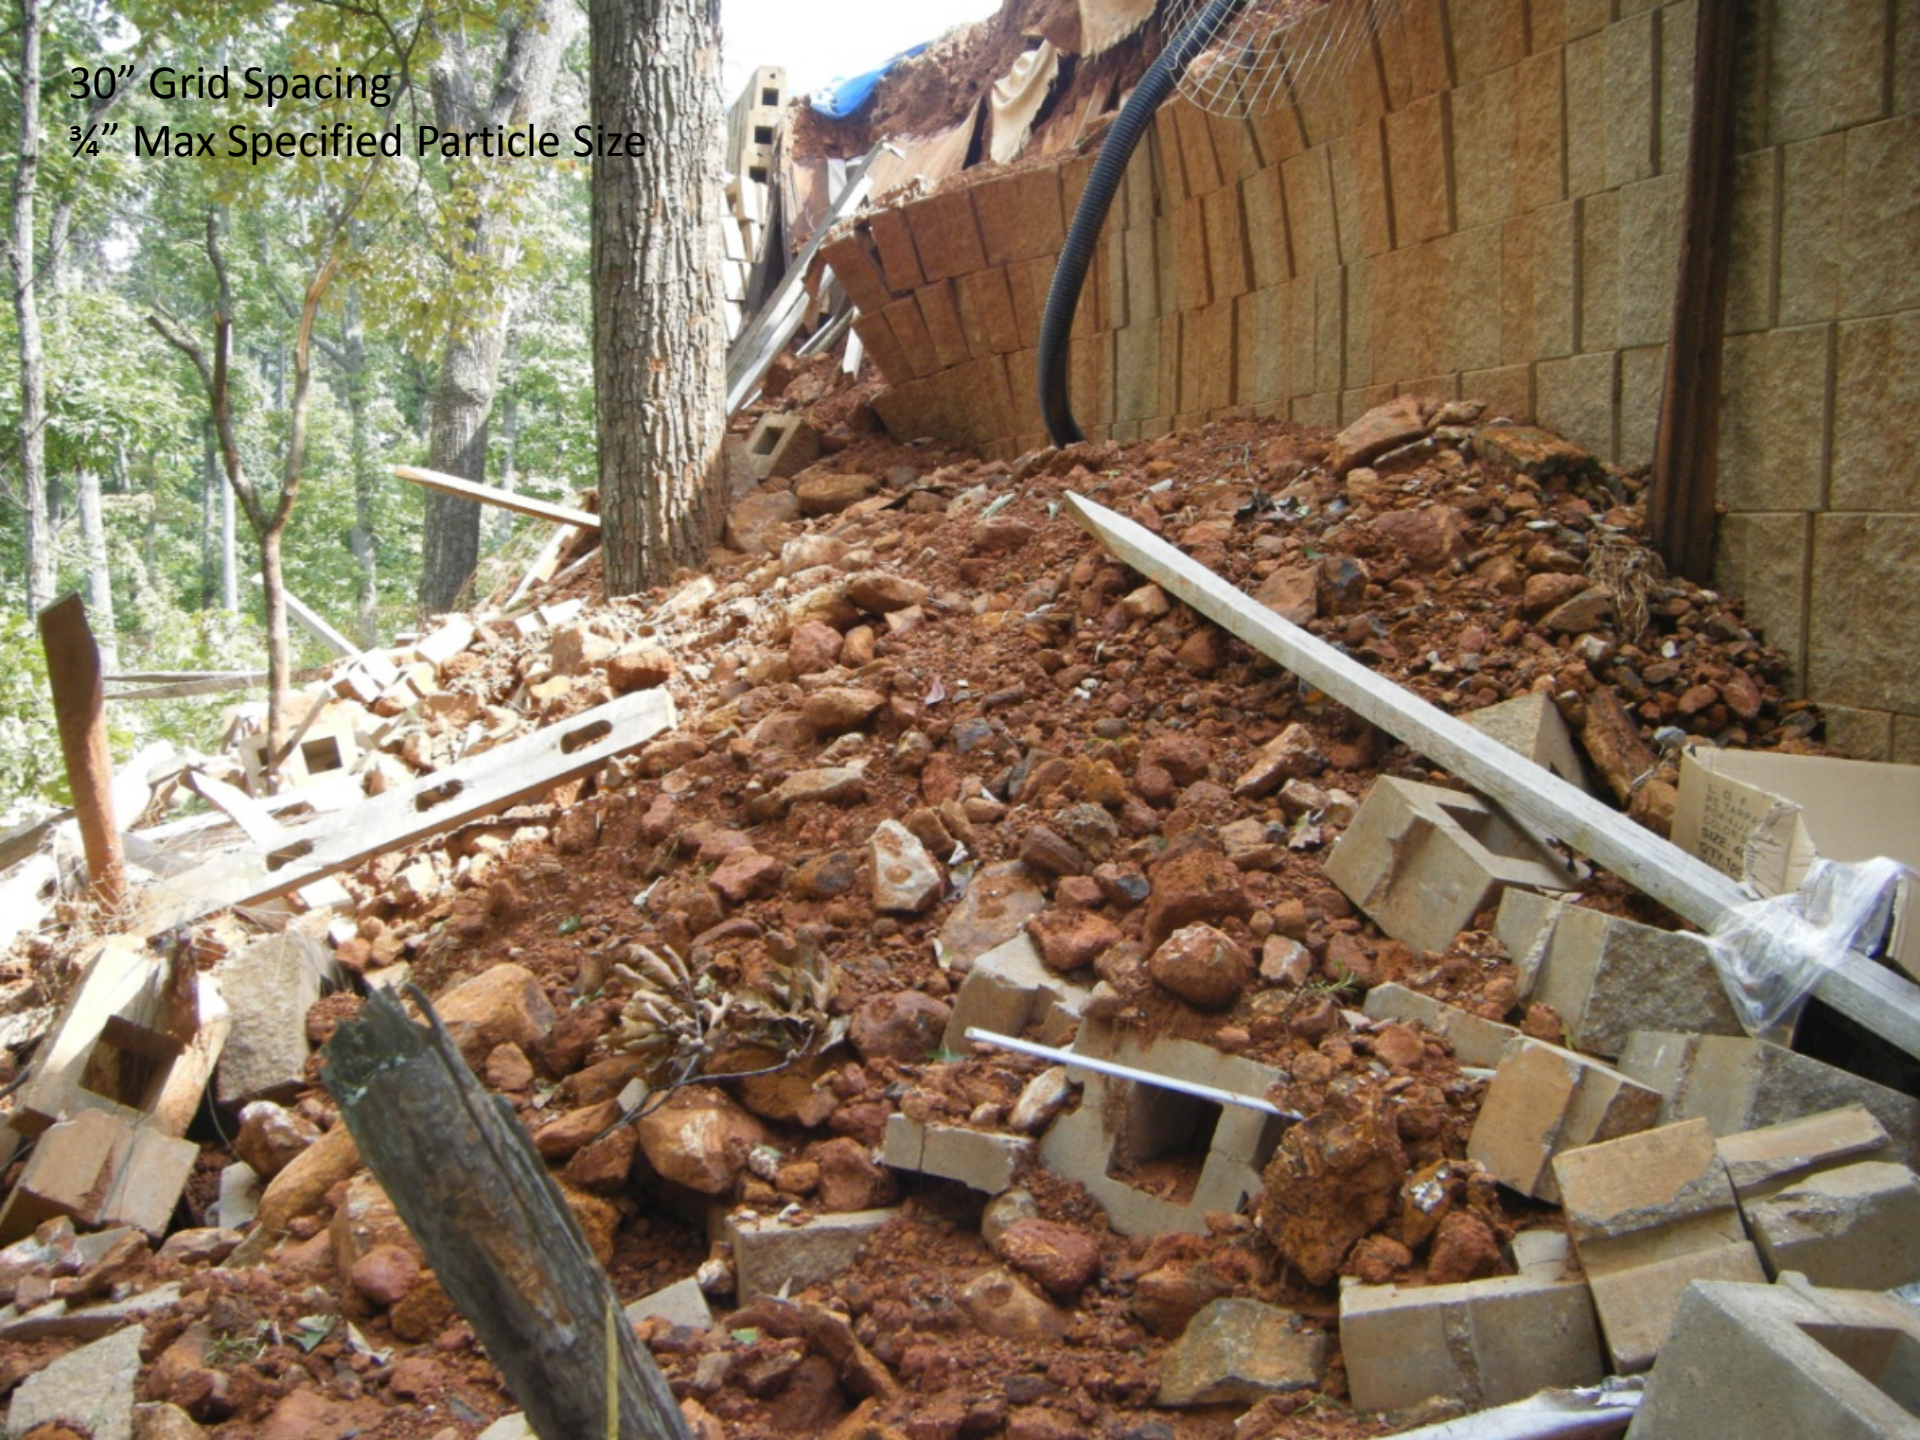
Non-Failed Sections
