### Mitigation of Abandoned Mine Entries at Swanbank Enterprise Development, Ipswich, Australia

#### 10<sup>th</sup> Interstate Technical Group on Abandoned Underground Mines Workshop Harrisonburg, VA

# Rhondda No. 5 Colliery Entry Tunnels Disturbances 11, 13, and 15

# New Hill Colliery Entry Tunnels and Air Shaft Disturbances D1, D2, and D3

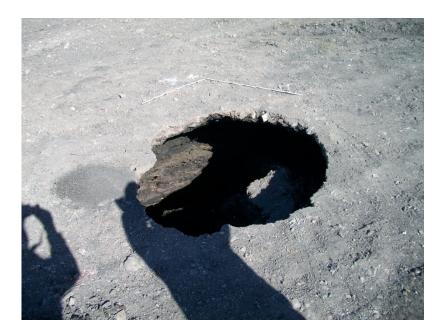
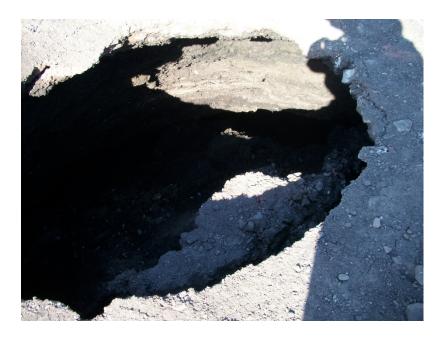
### Sinkhole Development During Drilling of 1<sup>st</sup> Grout Hole

#### **Sinkhole views**

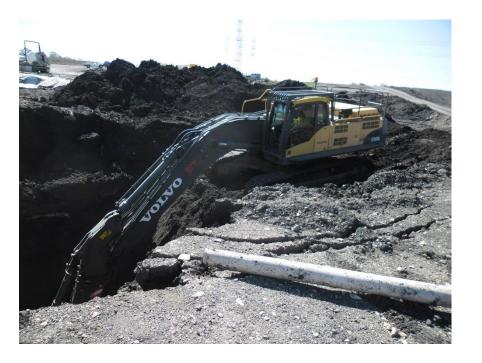
Sinkhole Test Pit con't

- Dug down to about 20ft (6m), just above arch, and could not dig deeper;
- Sinkhole may have been caused by disturbing backfill along the outsides of the arch or piping may have been occurring on the outside of the arch and the piping area collapsed.

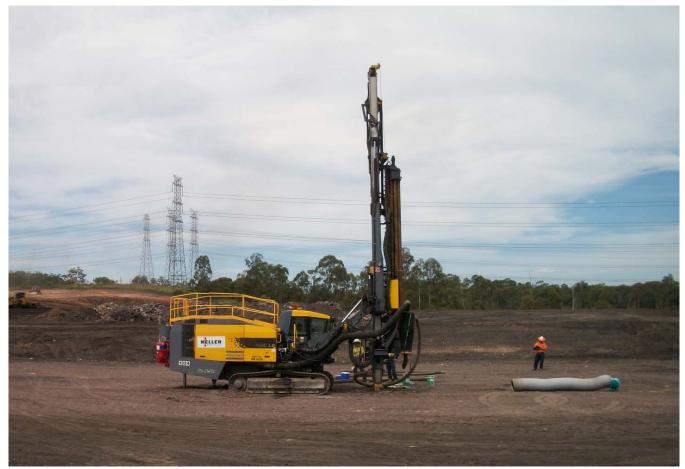
#### Drilling resumed with Atlas Copco L8 Rig over the portion of tunnel in rock, but stopped drilling since holes wouldn't stay open in the refuse material and rig could not install casing.

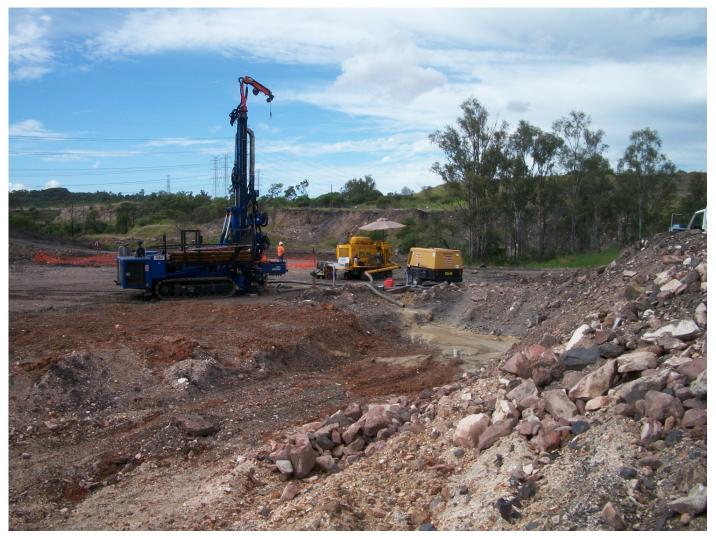
### Hutte Rig drilled remainder of grout holes in Rhondda area since it could install casing

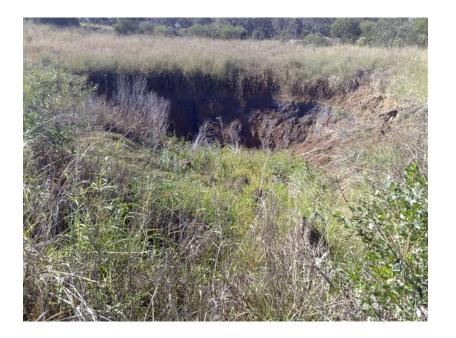
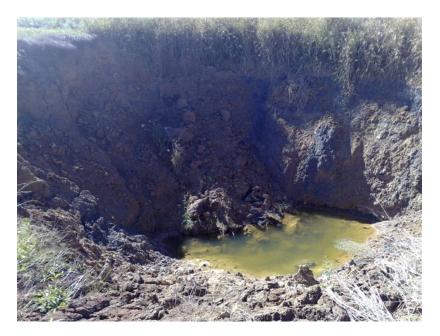
### Sinkhole over Belt Tunnel – May 2008 Approx. Dia = 26ft (8m) and Depth = 20ft (6m)

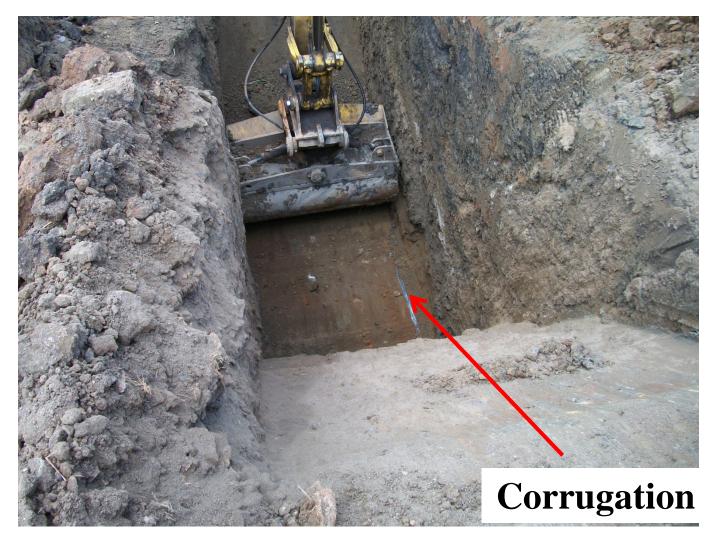
#### **Exposing upslope Corrugation in top of Armco section**

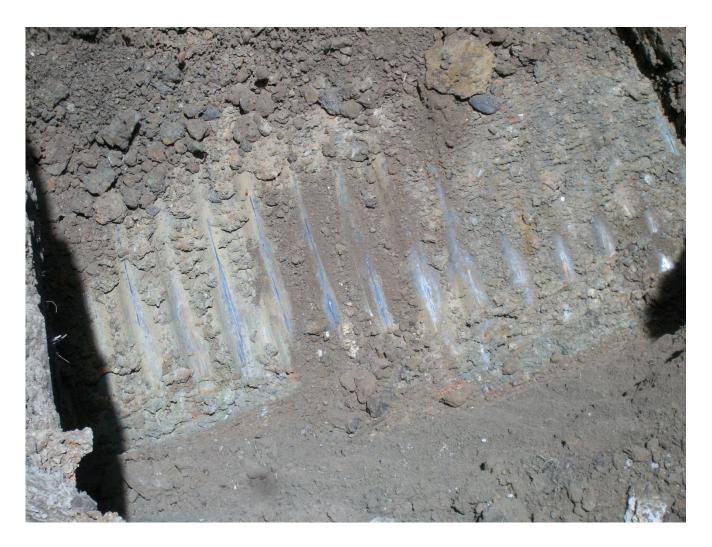
#### **Armco Arch Section Uncovered**

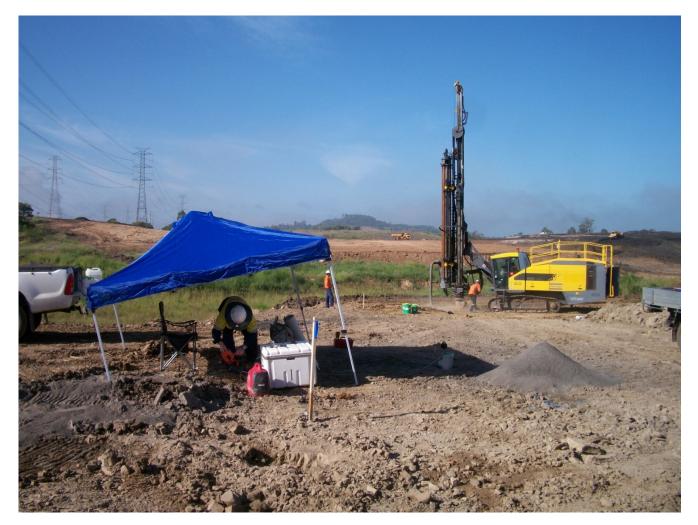
#### Tent for borehole camera viewing

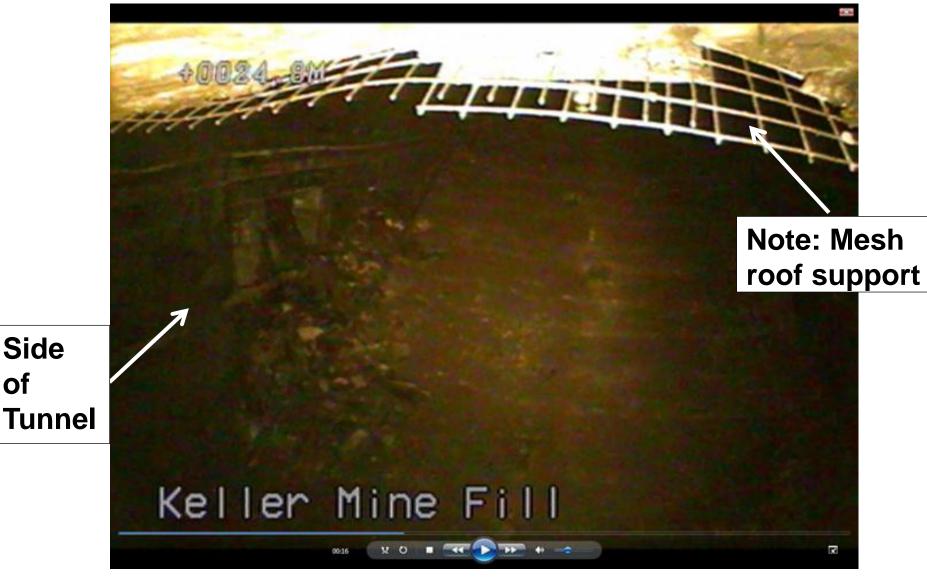
Man & Supply Tunnel (D1) – View looking up slope in rock tunnel

from NH1B1

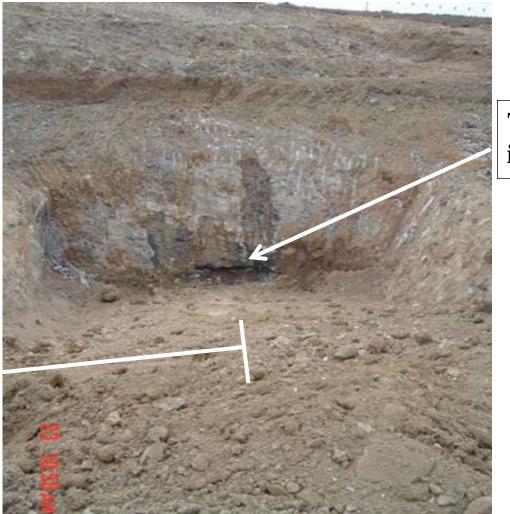
**Top of tunnel** in rock

Area where Armco tunnel was located

#### **Exposed Armco / rock tunnel interface in sinkhole over-excavation**

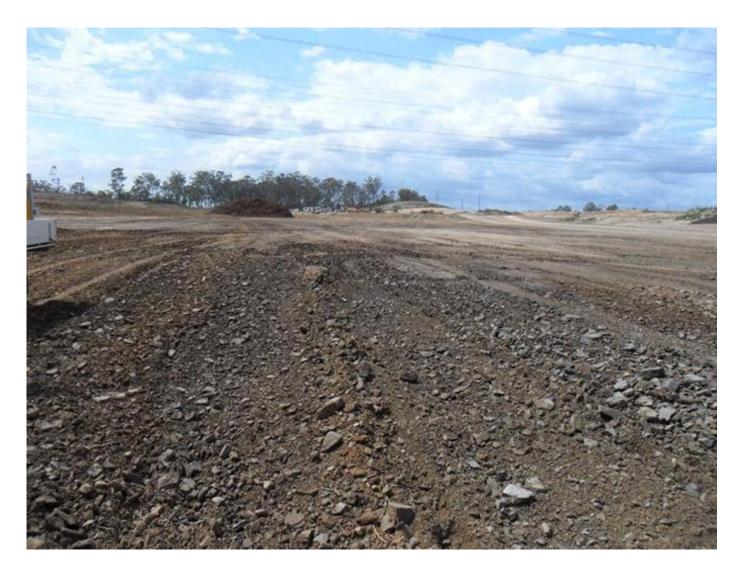
#### **Compacted backfilled sinkhole area**

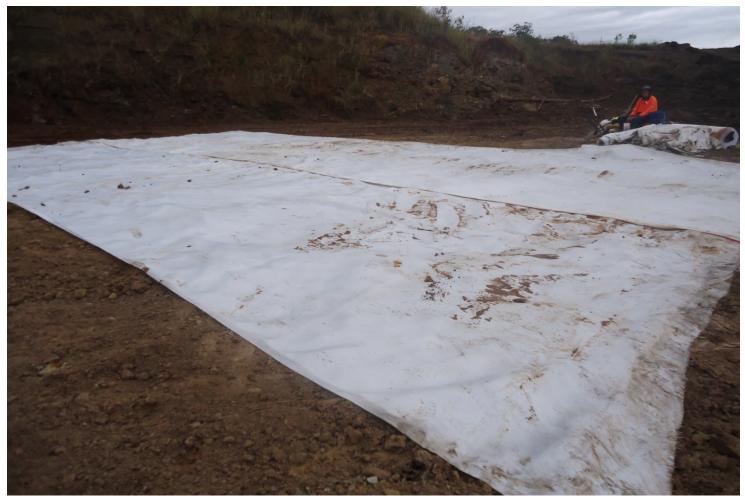
#### First geotextile layer spread over shaft

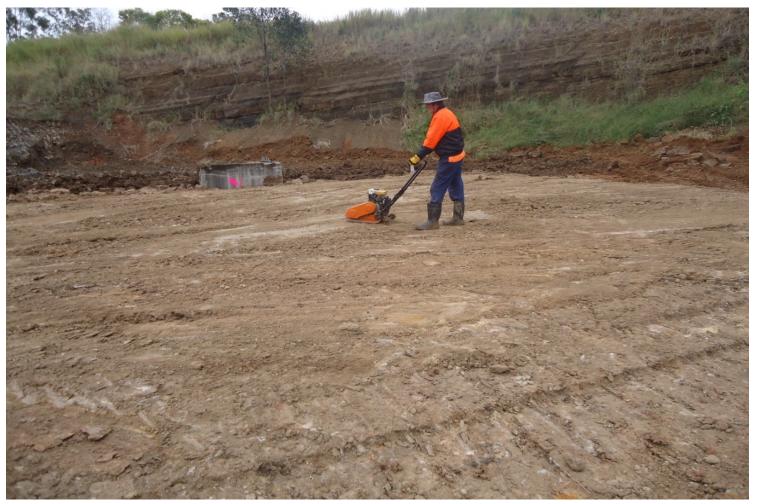
#### **Compacted fill after the third geosynthetic layer**

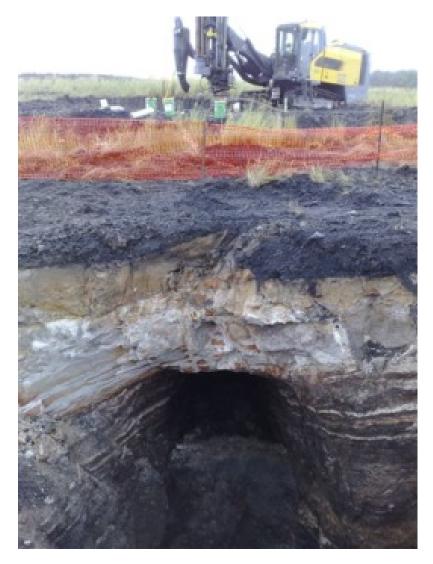
#### **Grout hole drilling**

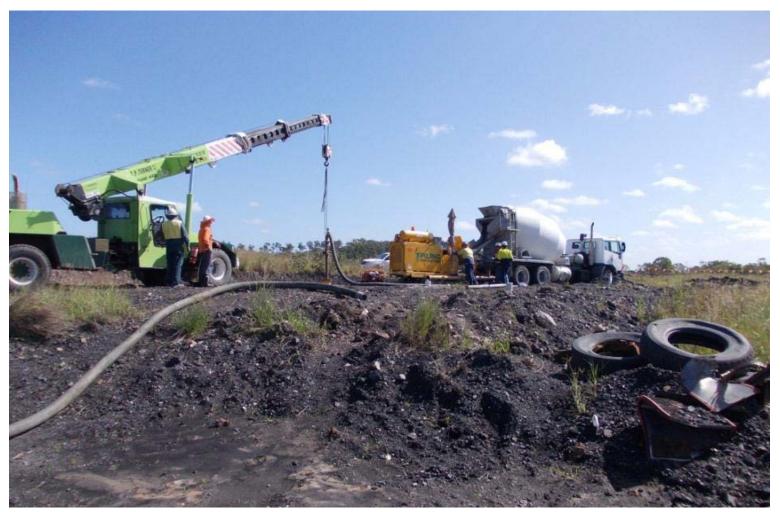
#### Grout being pumped from agitator truck into grout hole through tremie pipe

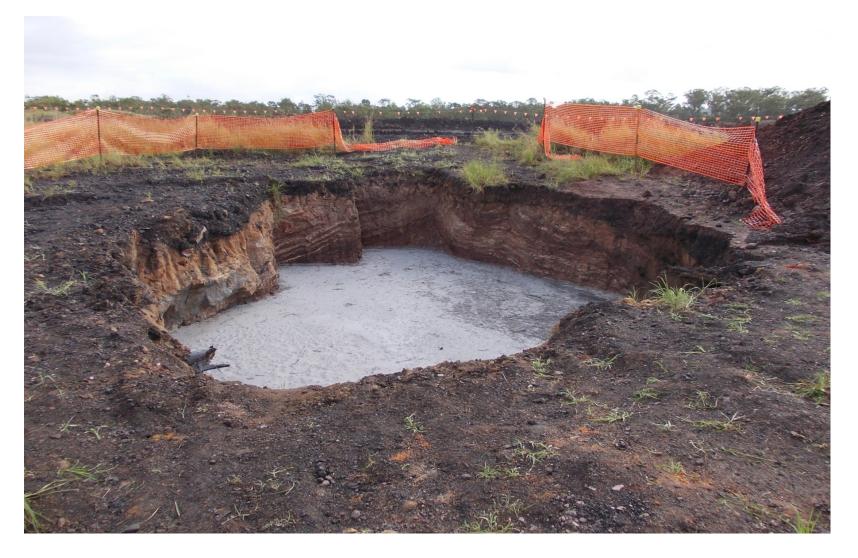
#### **Tunnel 2 after filling with grout**

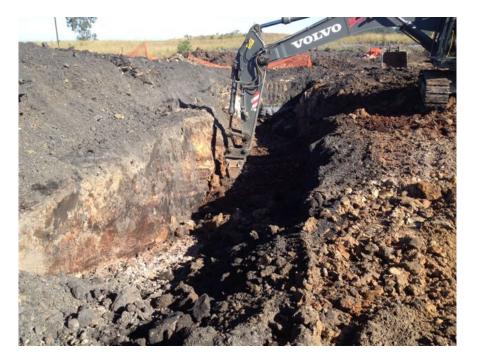
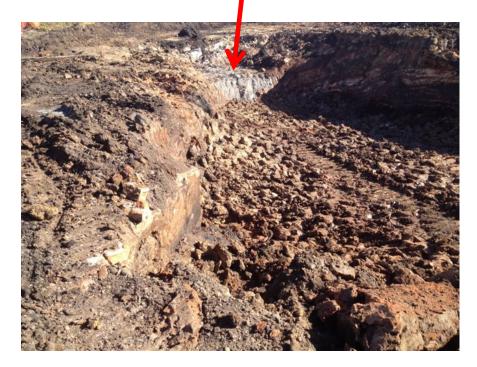
### **Over – excavation and backfill of tunnel section upslope from grout barrier**
